Spencer, Sullivan & Vogt
ARCHITECTURE • PRESERVATION

Conditions Assessment & Feasibility Study for the
LANSING MILLIS MEMORIAL BUILDING

64 EXCHANGE STREET, MILLIS, MASSACHUSETTS • 1 FEBRUARY 2021

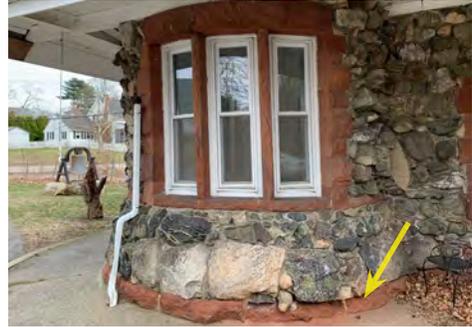
Red sandstone foundations are spalling throughout

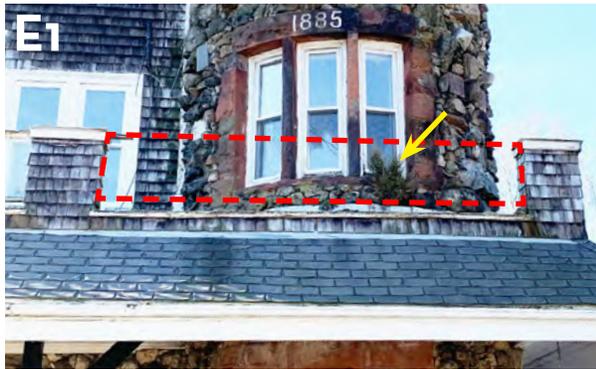
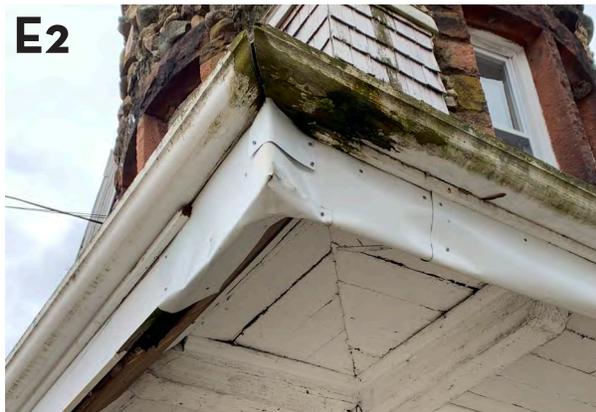
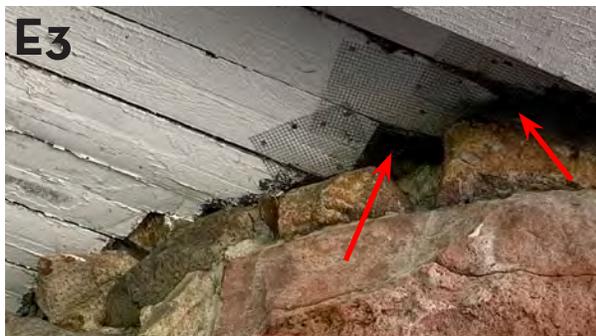
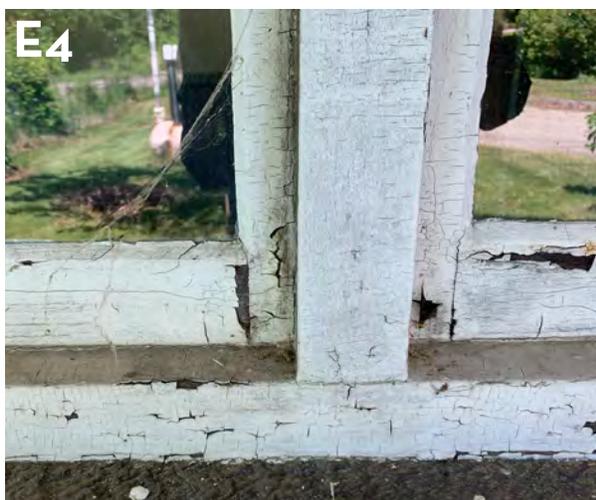
- The railings surrounding the balcony are significantly deteriorated. Two sections are completely missing. The former location of the missing east-facing element is outlined in red in Img. E1. The railings shown in historical photographs differ from these as they had significantly more balusters, suggesting that they are non-original. *The existing railing should be removed along with any remnants of the two missing ones. Missing railings should be replaced with wood replicas, closely modeled after those seen in historic photographs, p. 28.*

- Small trees have taken root in the reglet cut for the lead counterflashing at the intersection of the tower and the balcony's flat roof (see yellow arrow in Img. E1). Further observation suggests that all lead flashings and counterflashings around the building are beyond their usable lives. *All flashings and counterflashings should be comprehensively replaced while other roof work is ongoing.*

- Lead flashings and counterflashings around the building are deficient. The red arrow in Img. E7 identifies an area at the southeast corner of the balcony in which a counterflashing has come loose. *New base and counter flashing should be installed as part of the roof replacement recommended above.*

- While wood shingle siding is generally in fair condition, it will remain useful for no more than a decade. Weathering is evidenced by some loose shingles (see red arrows in Img. E8) and extensive ‘cupping.’ Historic photos suggest that shingles were coated, likely to protect them from the elements. *A comprehensive restoration of the building should involve replacement of all wood shingle siding. Though optional, staining the siding is recommended, as it would emulate the building’s historical appearance and slow damage.*

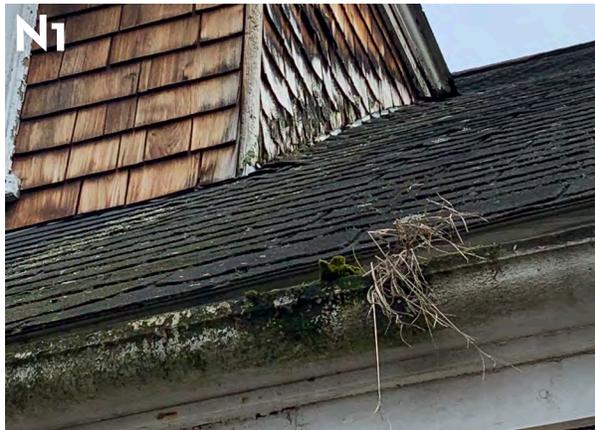
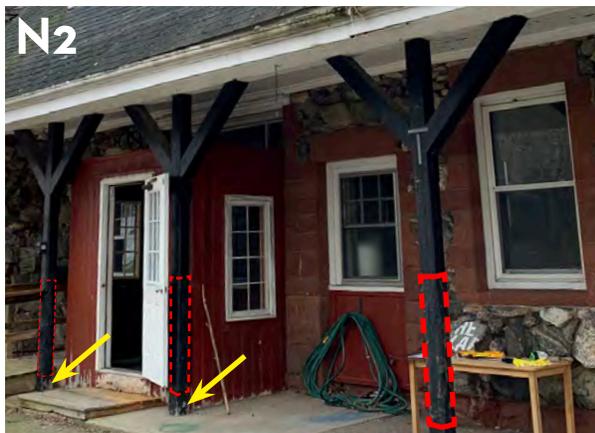
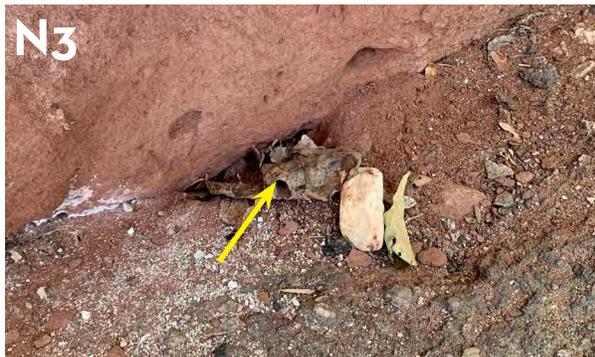
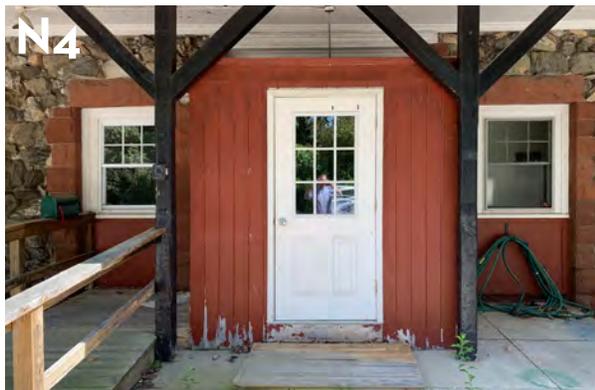
- Image N1 further illustrates the severe degradation of wood gutters around the building. In this case, sediment build-up within the gutter has allowed grasses to take root, in addition to the more typical mosses and lichens. *As discussed earlier, all elements of the cornice should be removed and replaced at all four elevations.*

- Black painted posts supporting the overhanging roof have experienced significant rot over time. Though they appear to be in sound condition upon first glance, closer investigation shows that most of the columns' lower portions have been wrapped in a thin sheet metal (see areas outlined in red in Img. N2). Knocking on the metal coverings reveals that they are mostly hollow underneath. This is a typical pattern of decay; lower portions of wood columns often wick water upwards from the ground (especially if it is paved, as in this case). Rot is visible below the metal coverings (as identified by yellow arrows in Img. N2). *Closer investigation of the condition of the columns necessitates removal of the sheet metal, at which point a better-informed approach for their repair can be determined. It appears as though most columns will only need some additional structural support via metal stand-off bases and new concrete masonry piers, though some may require replacement.*

- The area outlined in red in Image N7 identifies the location of the second of two missing railings (*where, as previously discussed, a wood replica should be installed*).

- Most elements of the north dormer, including the asphalt roofing, flashings, wood shingle siding, and windows have been previously discussed in earlier observations. *The remaining elements, the cornice and soffit are somewhat degraded. Wood replacements should be fabricated to match the profile of the existing installed in their place, and painted to match other exterior wood trim (see Img. N8).*

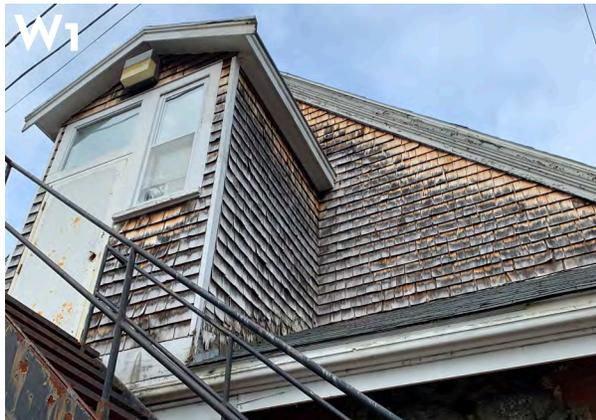
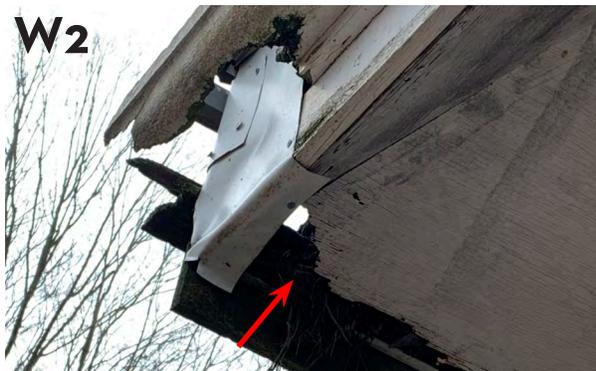
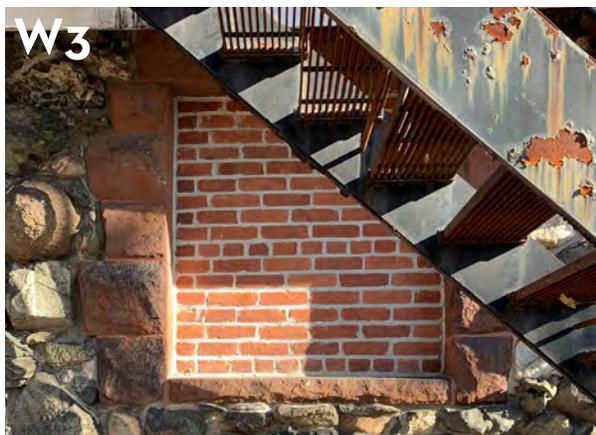
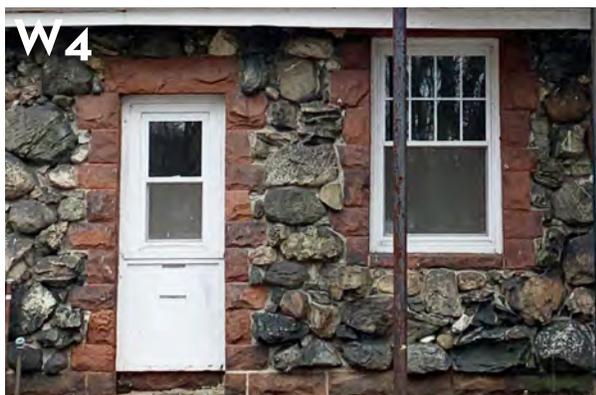
- The egress addition and fire escape are not original to the building and were likely added to meet code requirements sometime in the latter half of the 20th century. *All reuse schemes discussed in Part Three of this report call for the removal of these elements, as the additional means of egress would not be code-required for the proposed occupancy uses. The resulting holes in the west wall and roof should be patched to match their surroundings, which, in the case of the latter, will involve installation of new roofing and flashing infill. The existing window on the west face of the addition should be salvaged for re-installation at the right side of the new wall.*

- As discussed in earlier observations in this section, the building's cornice and gutters are in irreparable condition; corners have faced the most severe damage. Image W2 shows the southwest corner of the roof, which has rotted away almost entirely. One or more repairs has evidently been attempted with sheet metal and there appears to be a nest inside the gap (see the red arrow). Deficient gutters have also allowed the angled, outermost portions of the soffit to rot. *The only appropriate way to repair damage to the gutters and cornice is to comprehensively replace them (as discussed on page 42). Any damaged soffit boards should also be removed, replaced, and painted to match the surrounding wood trim.*

- Though the gable cornice is in sound condition at the east elevation (perhaps due to better maintenance resulting from higher visibility), the cornice at the west-facing gable is severely damaged. Some portions of the molding are missing altogether (see areas outlined in red in Img. W5), allowing water to enter the building envelope. Repairs with sheet metal have also been attempted (as identified with the yellow arrow). *Because damage is largely confined to the lower portions (near the wall's intersection with the hip roof), a cost-effective treatment would involve replacing deteriorated portions with matching wood infills.*

- The existing second-floor window at this elevation, like most of the other windows, is a vinyl replacement. *Upon re-installation, the window salvaged from the addition should mirror this one about a vertical axis from the roof peak. Though both are in working order, they should eventually be replaced with a more historically-appropriate wood windows, painted with the color identified by paint analysis.*

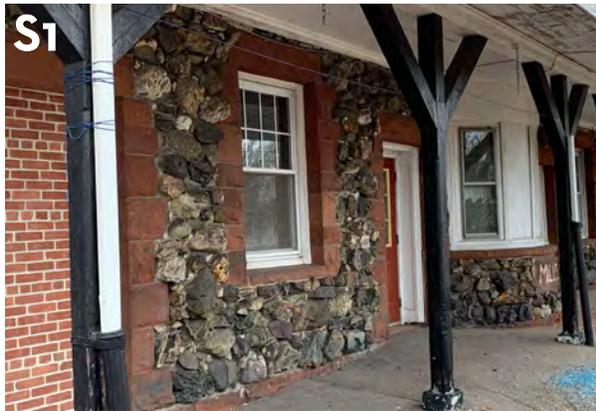
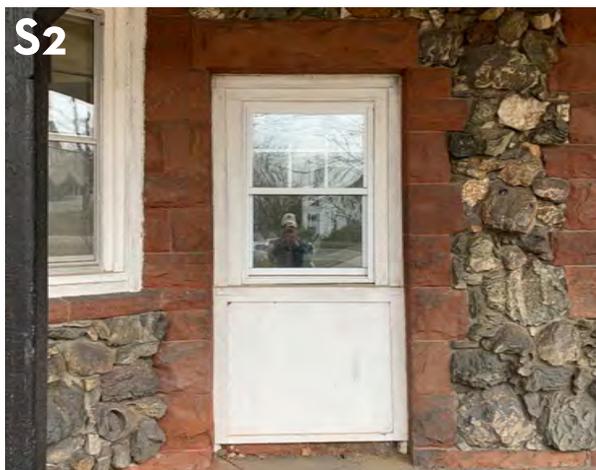
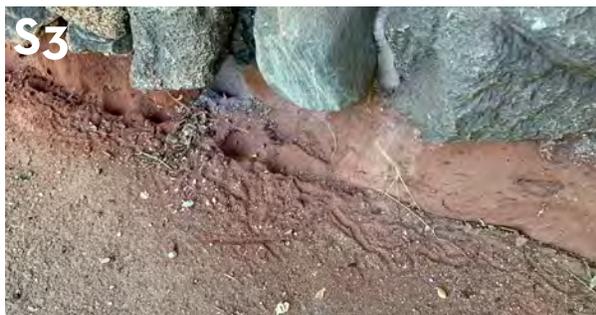
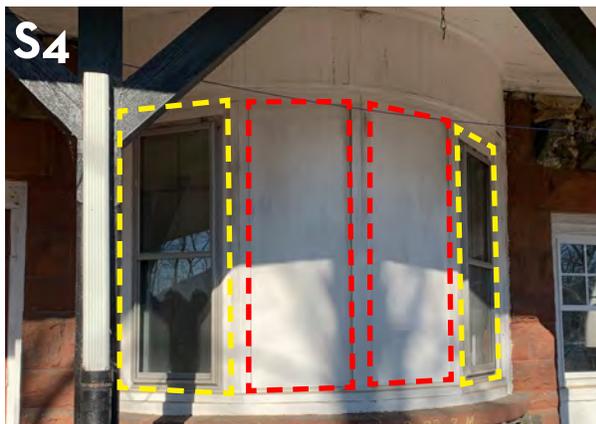
- Wood posts supporting the overhanging roof at the south elevation are in similar condition to those at the north. On some, rot has been covered with sheet metal which was subsequently painted over. *Wood posts at this elevation should be assessed and replaced as discussed for those at the north elevation, with additional structural support provided via metal stand-off bases. Some may require complete replacement.*

- Image S2 shows another masonry opening which was evidently designed and built for a door, but was later repurposed as a window. Similar to the north elevation, this opening is mirrored on the other side of the protruding bay window. However, the building's secondary entrance/exit door is situated in that opening, where the presence of a lever handle here suggests that it was installed to provide accessibility to the first floor. Historical photographs suggest that both of these openings previously served as doors. *Two historically-appropriate doors (with frames) should be fabricated for installation in these openings.*

- About 90% of the gutter at this elevation has either fallen off or been removed completely. It fortunately appears as though the gutter was lost fairly recently, judging by the mild level of decay of the remaining fascia. Gutter and cornice replacement, as discussed in several earlier recommendations, will remediate this problem.

- As with its counterpart at the north elevation, most of the south dormer's exterior elements have been previously discussed in earlier observations. The cornice should be replaced as part of a comprehensive roof replacement project and painted to match other exterior wood trim (see *Img. S7*).

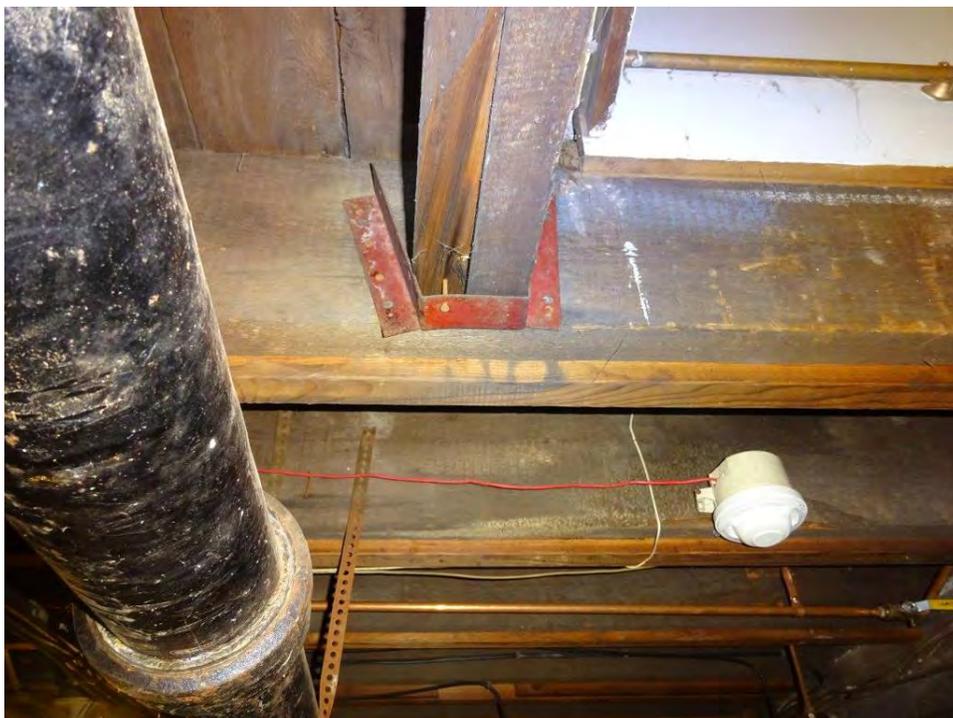
Photo 6
Improperly installed hanger at stair header-trimmer connection

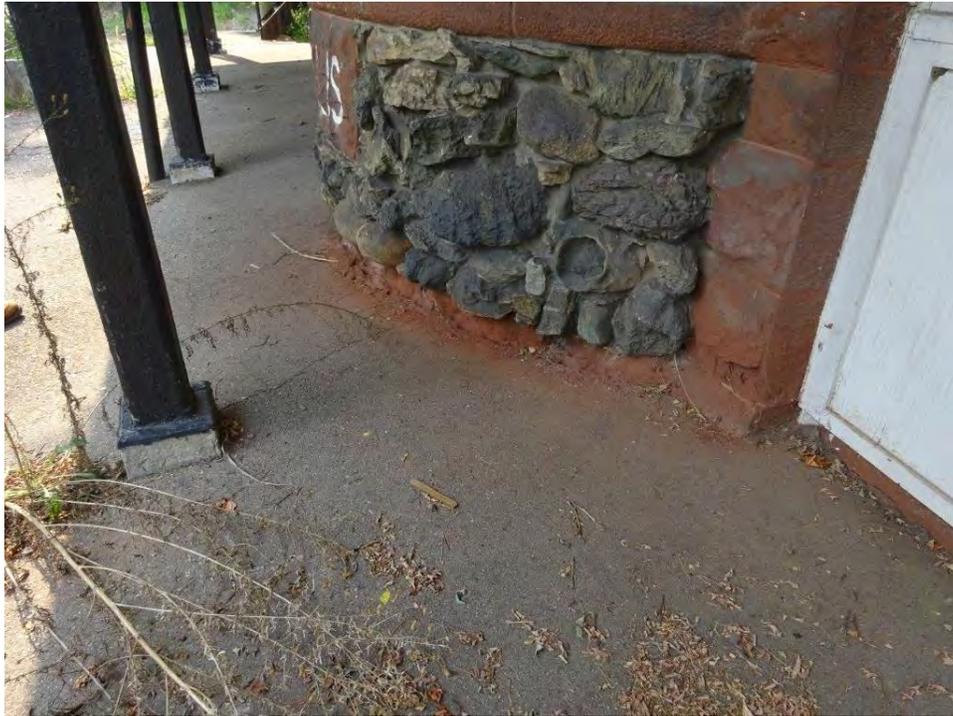
Photo 11: Deteriorated brownstone sills at base of walls at south elevation

Photo 11
Deteriorated brownstone sills at base of walls at south elevation

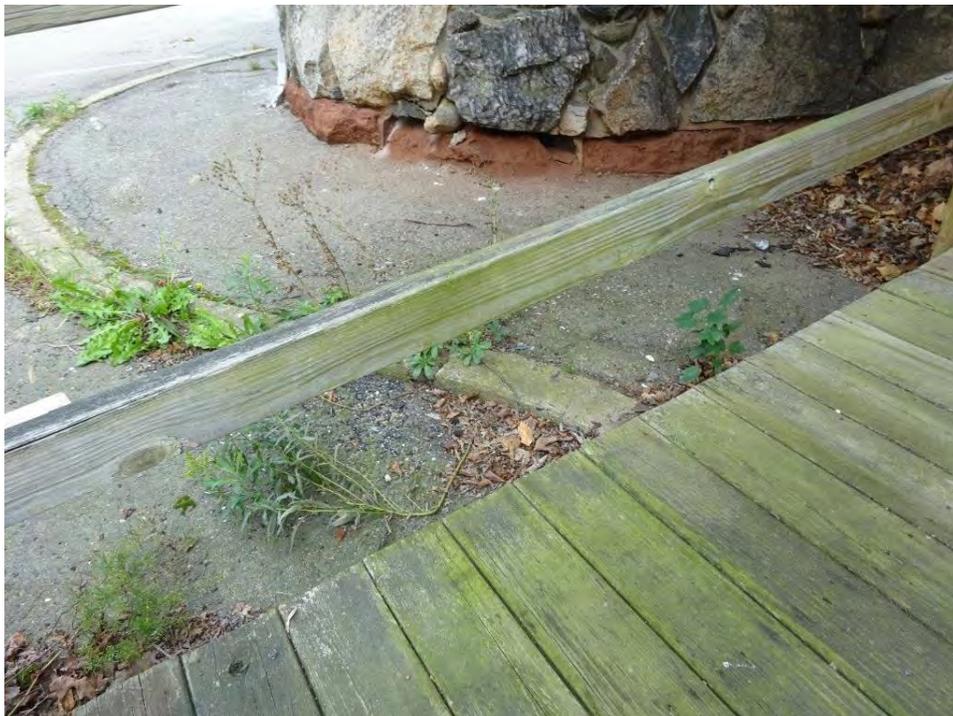
Photo 12: Deteriorated brownstone sills at base of walls at north elevation

Photo 12
Deteriorated brownstone sills at base of walls at north elevation
