Town of Millis

Police & Fire Station Project

MONTHLY PROGRESS REPORT

Report No.18

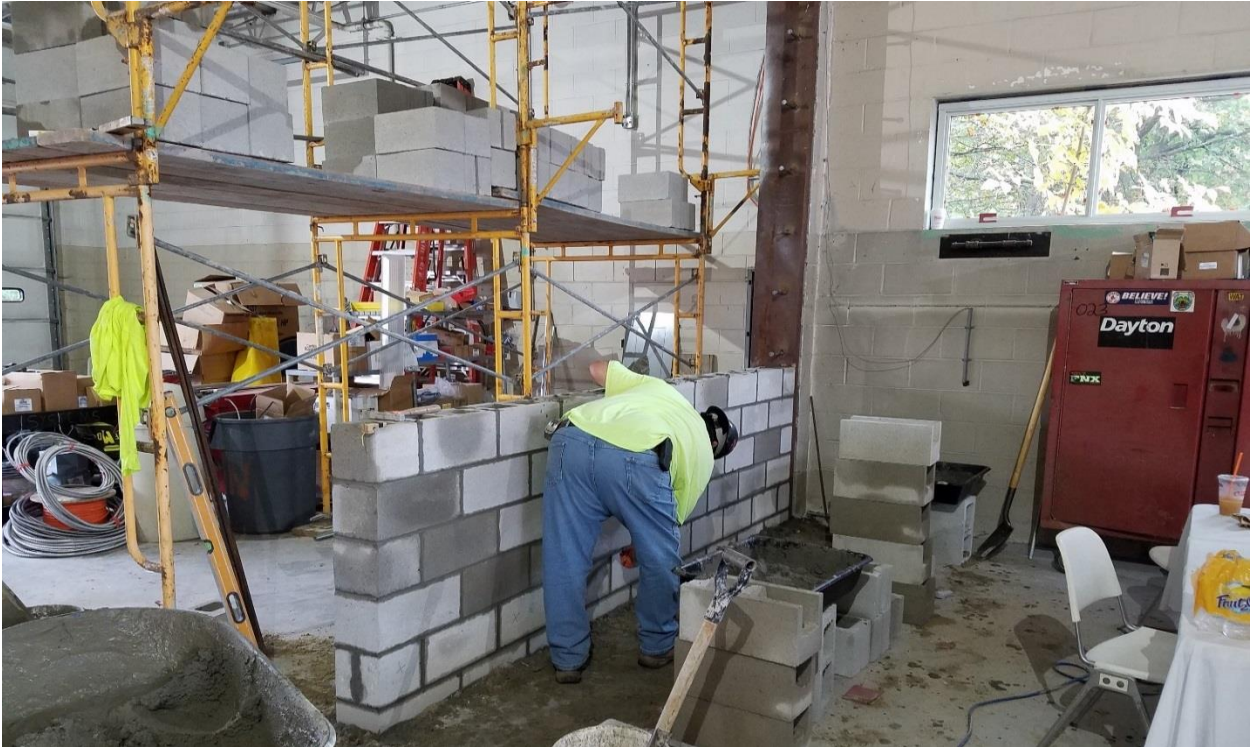
NEW INTERIOR CMU WALL in APPARATUS BAY 11-7-16

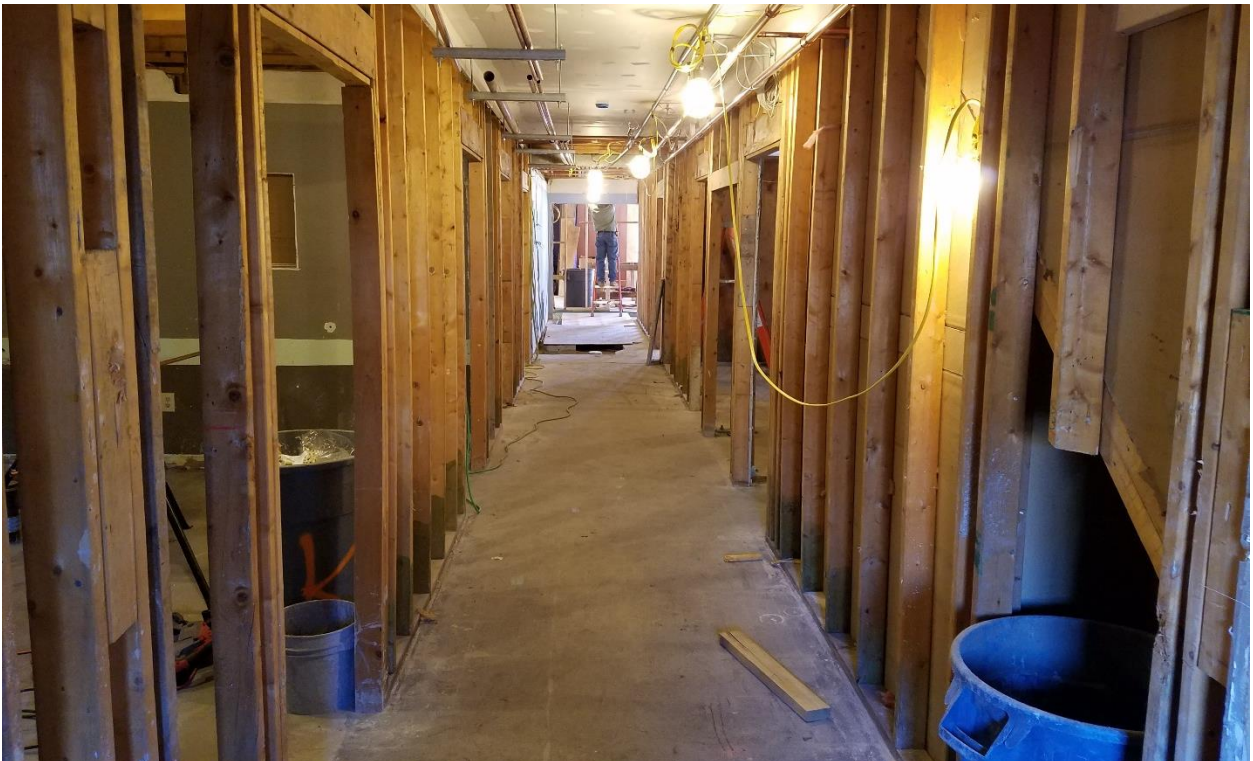
ADMINISTRATION CORRIDOR looking South 11-7-16

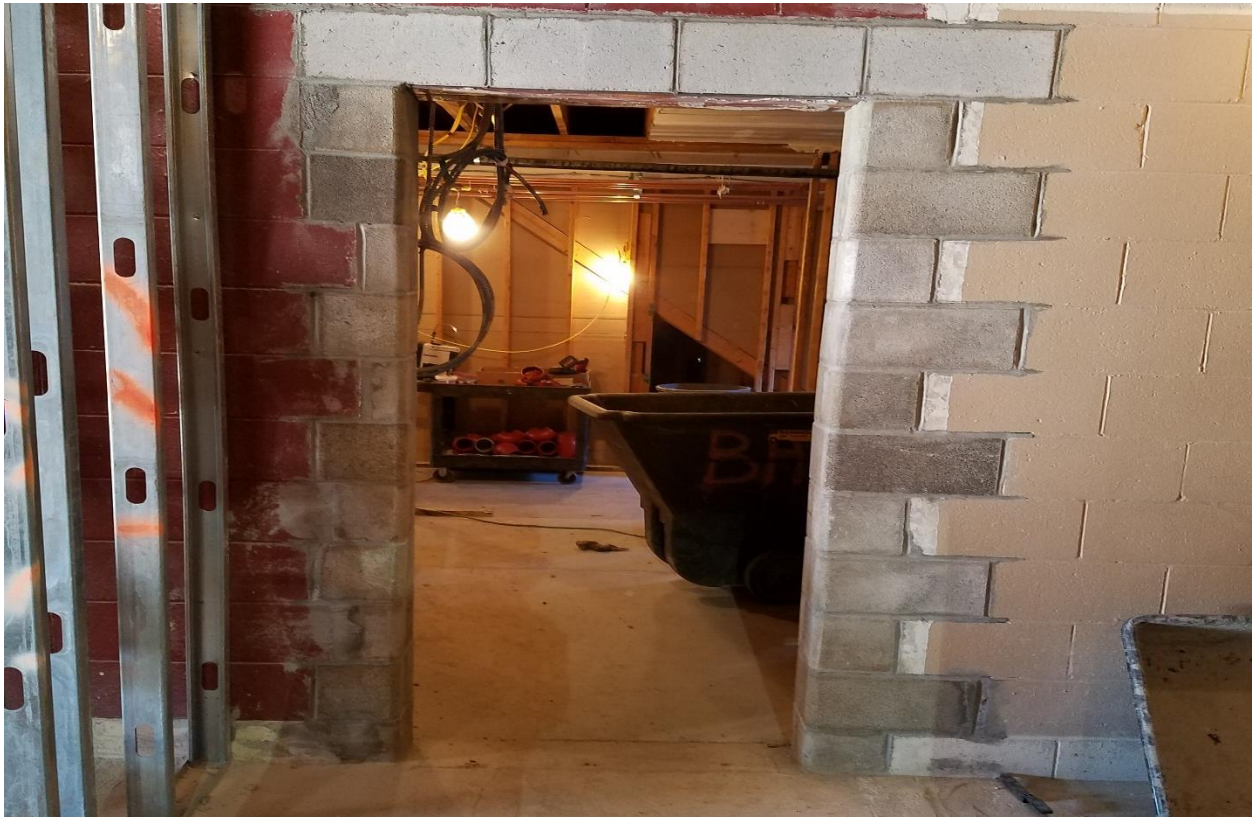
NEW CMU OPENING TO DECON 11-16-16

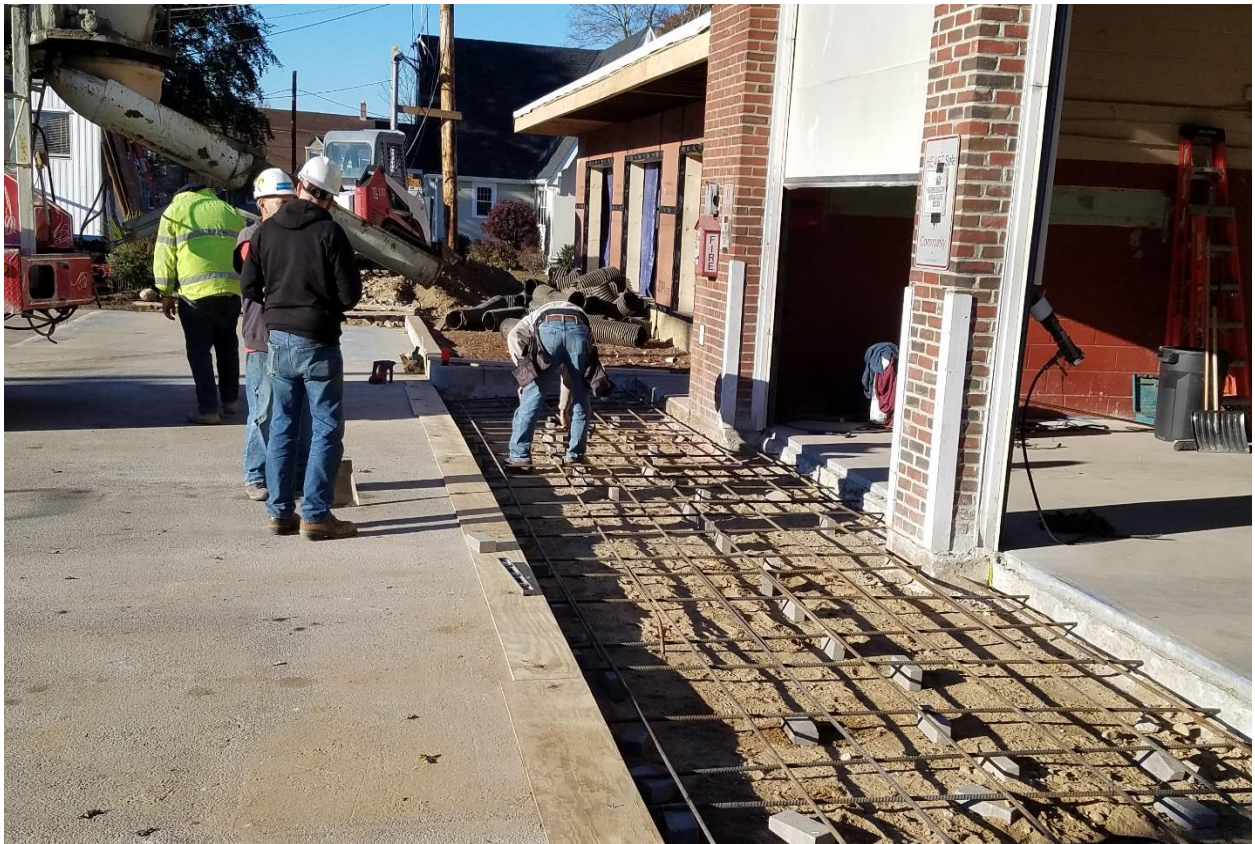
PLACING NEW CONCRETE APRON 11-8-16

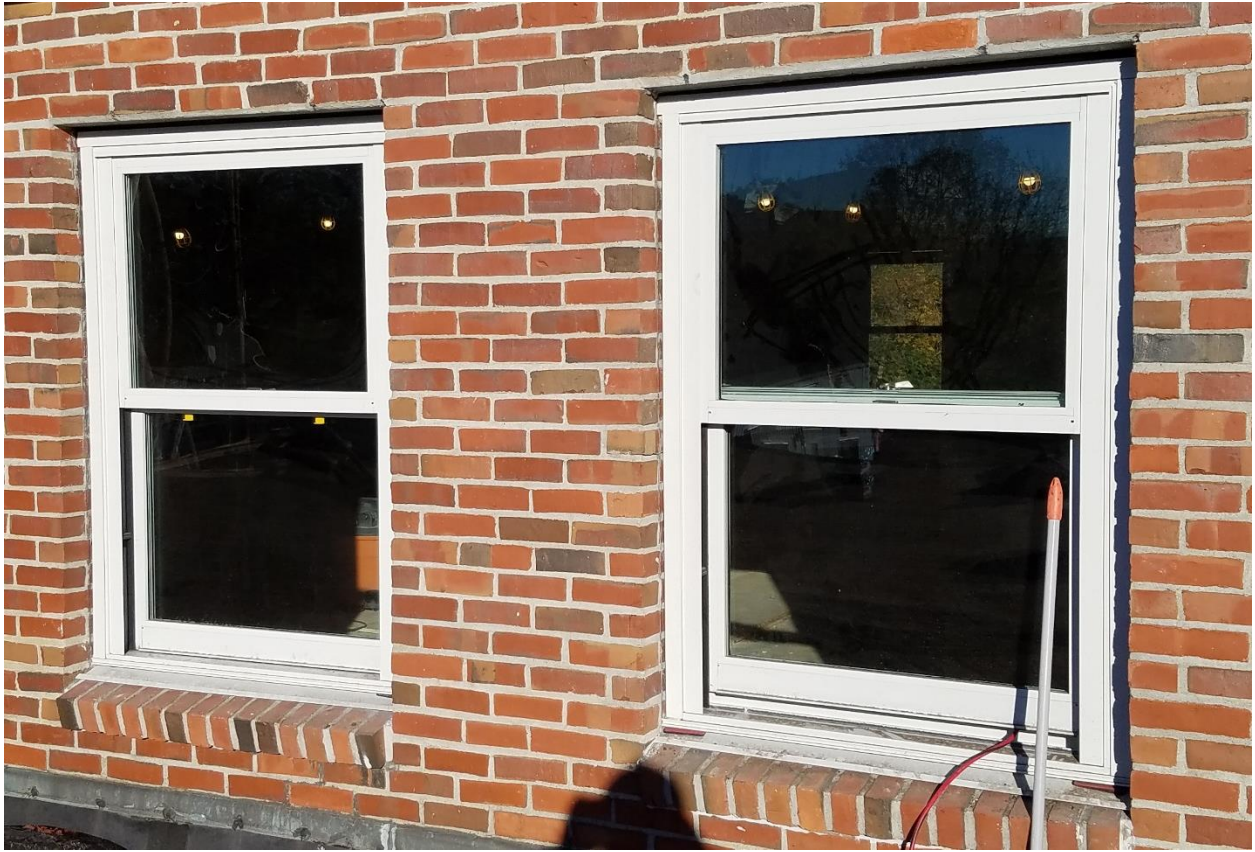
NEW ALUMINUM WINDOWS INSTALLED 11-1 -16

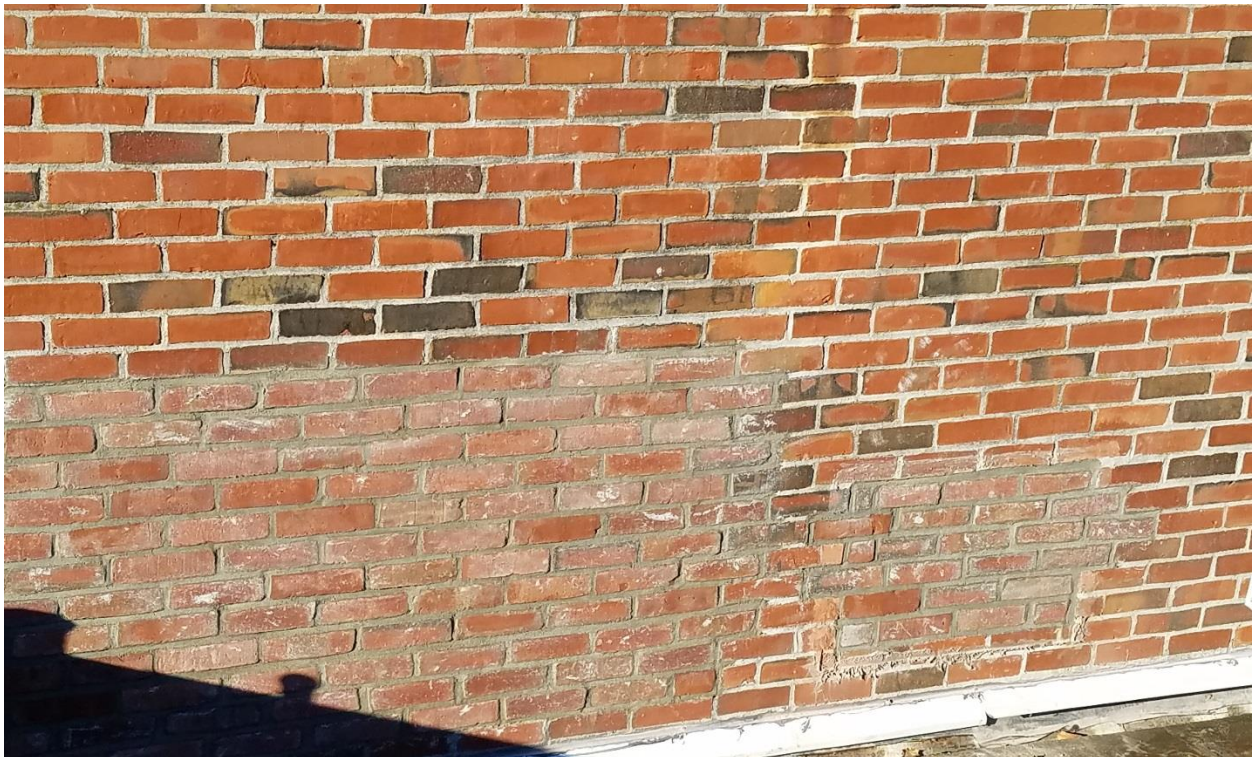
BRICK INFILL AT ABANDONED OPENINGS 11-18 -16

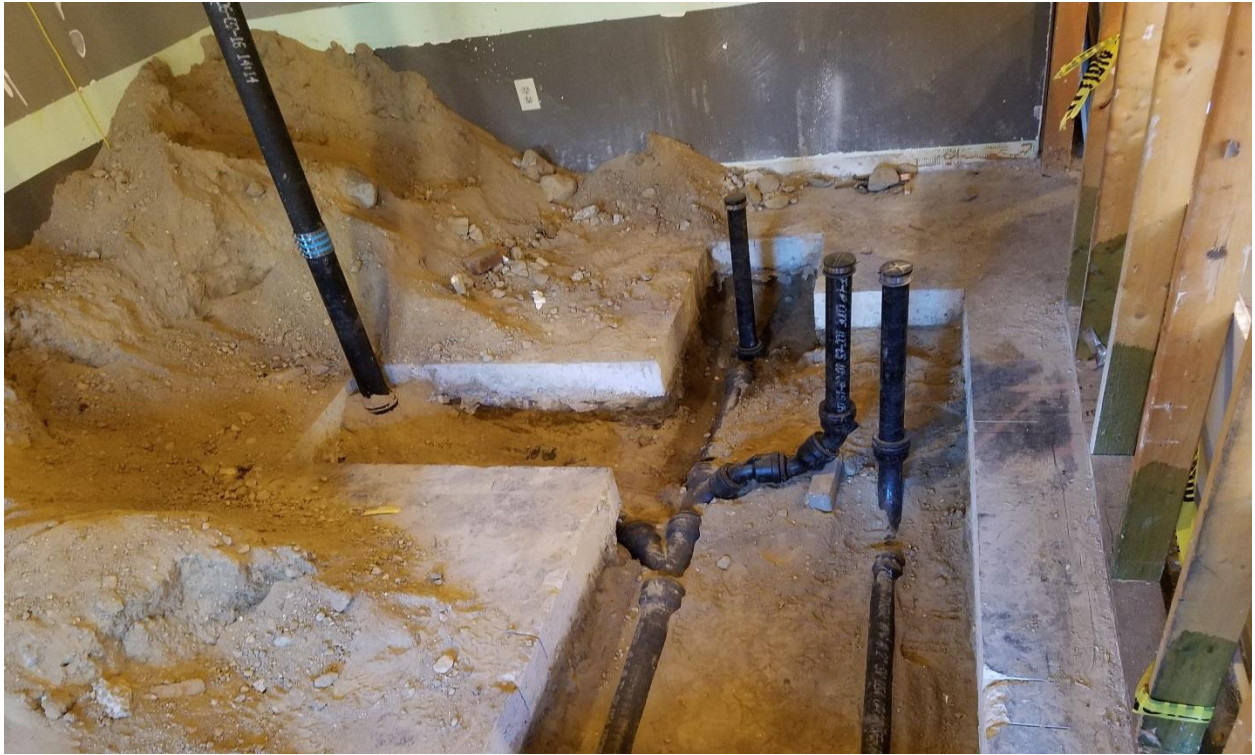
NEW UNDERGROUND PLUMBING 11-2 -16

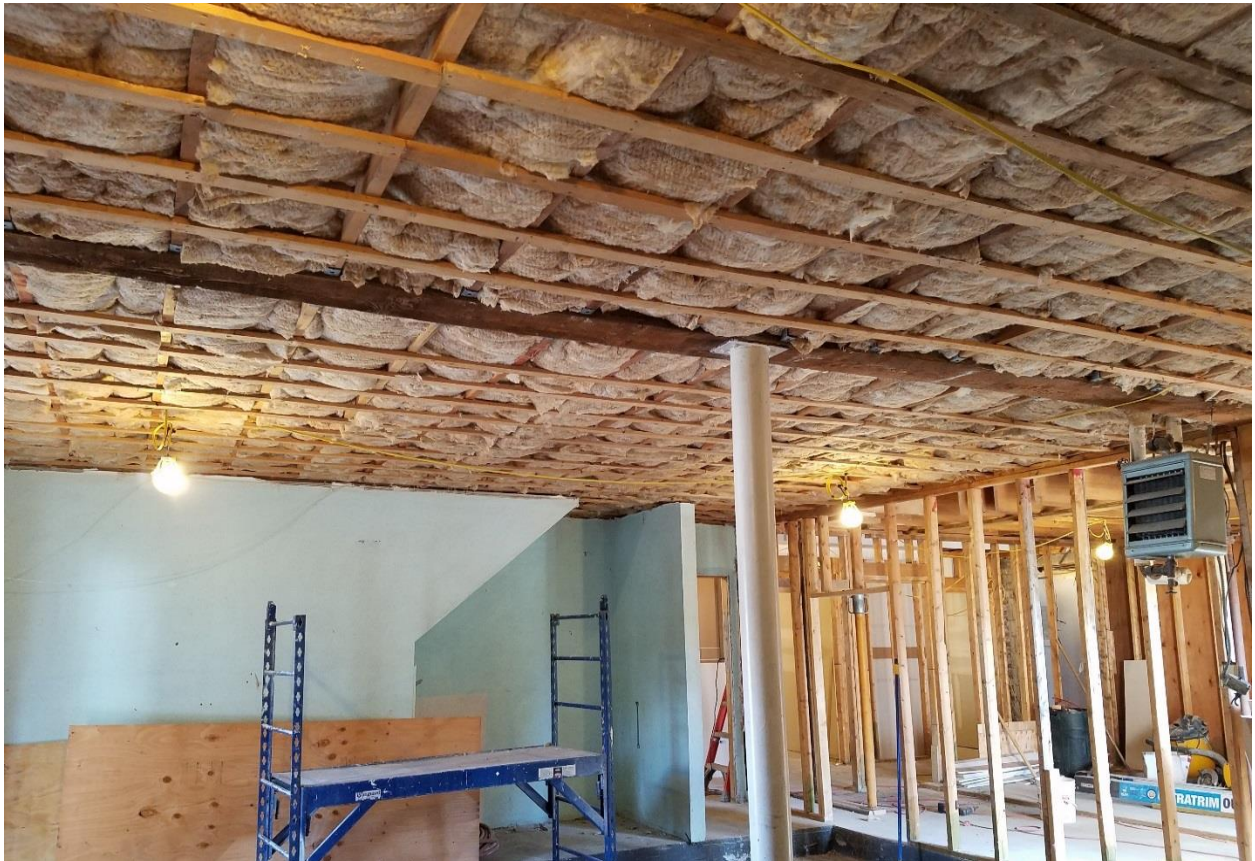
INSULATION OF FORESTRY GARAGE AREA 11-2 -16

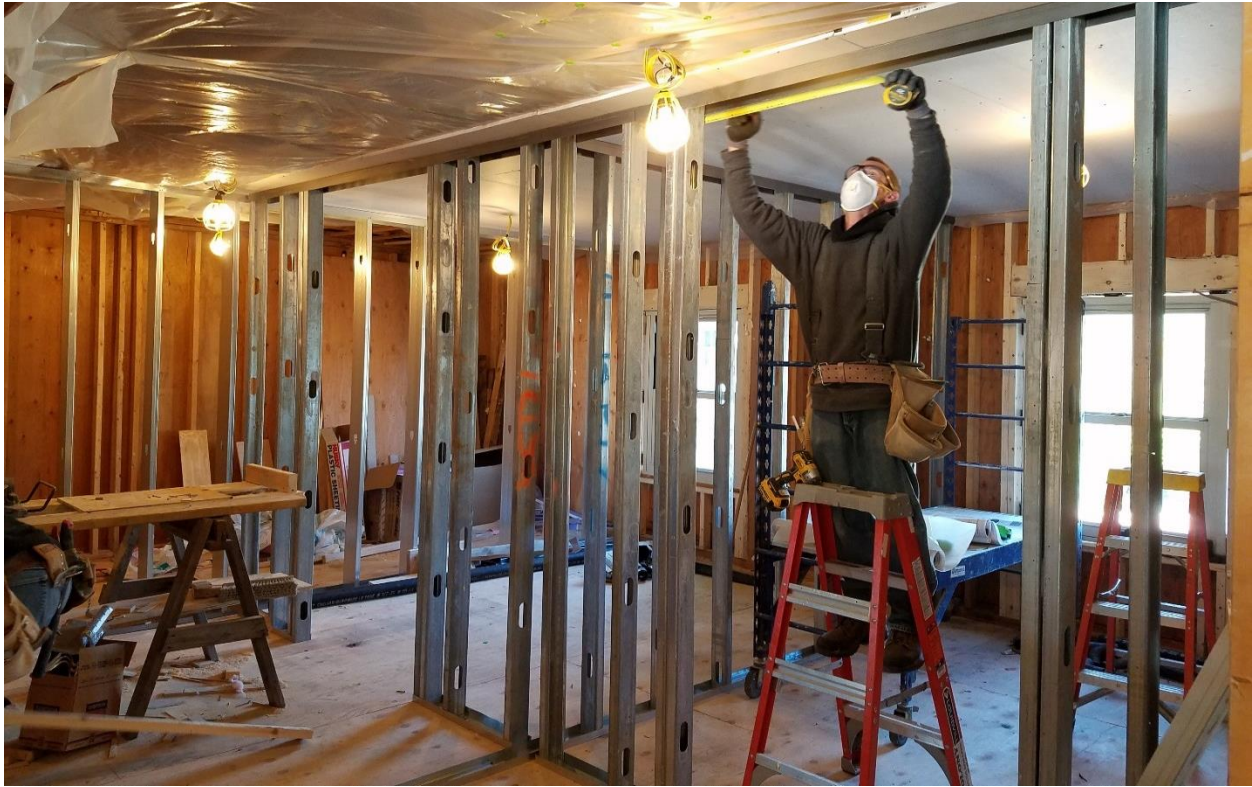
NEW SECOND FLOOR PARTITIONING 11- 2 -16

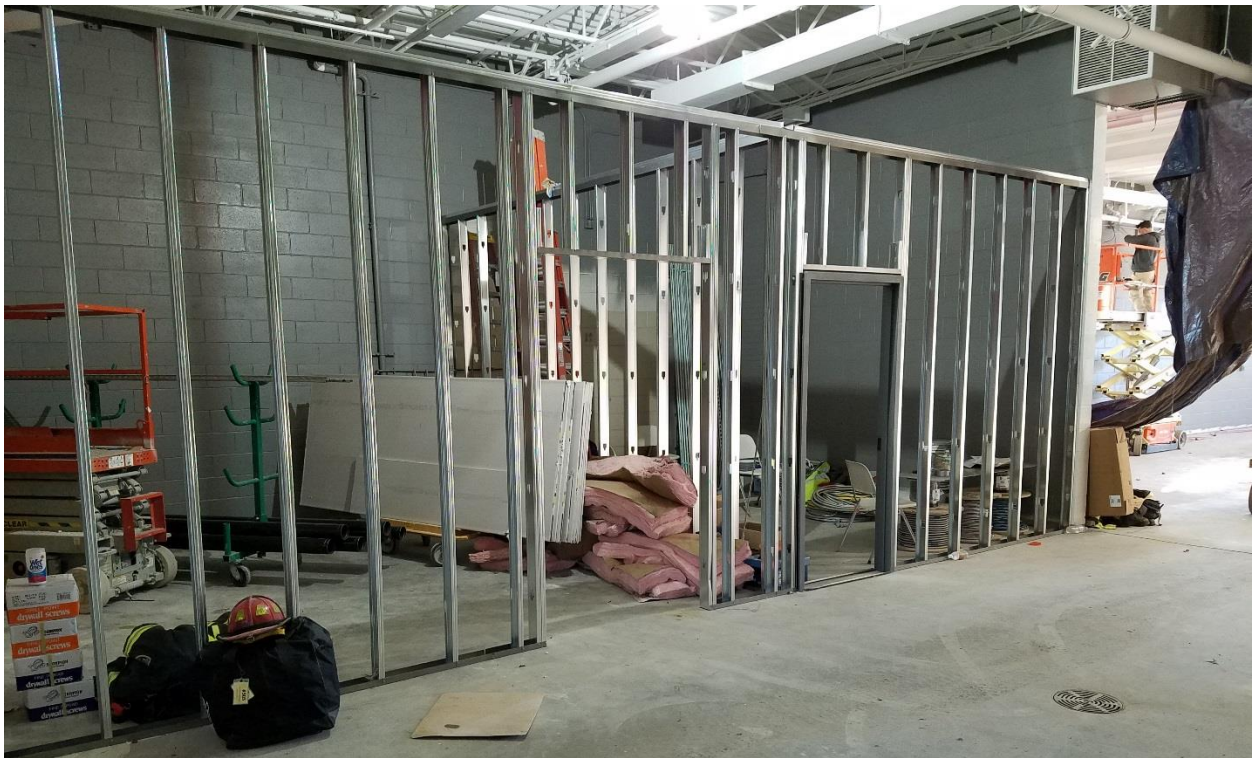
NEW FIRST FLOOR PARTITIONING 11-23 -16

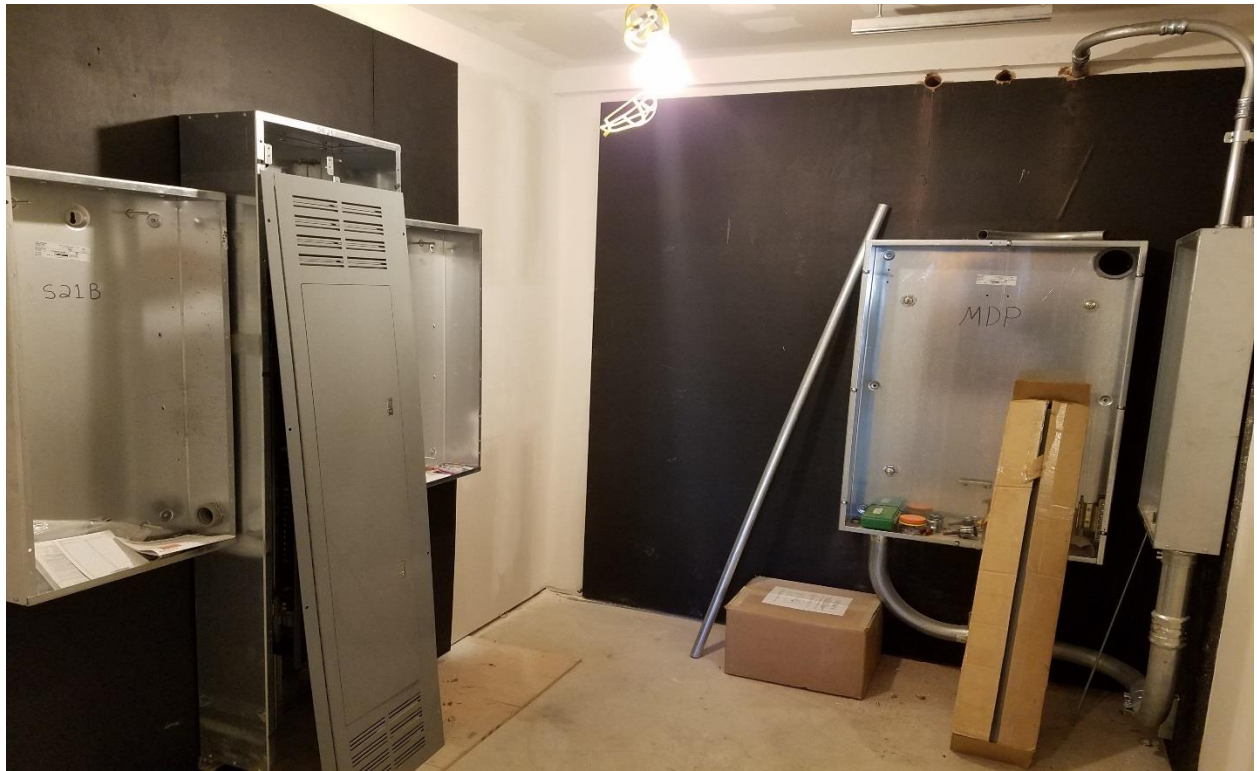
MAIN ELECTRICAL ROOM PANEL TUBS SET 11-21 -16

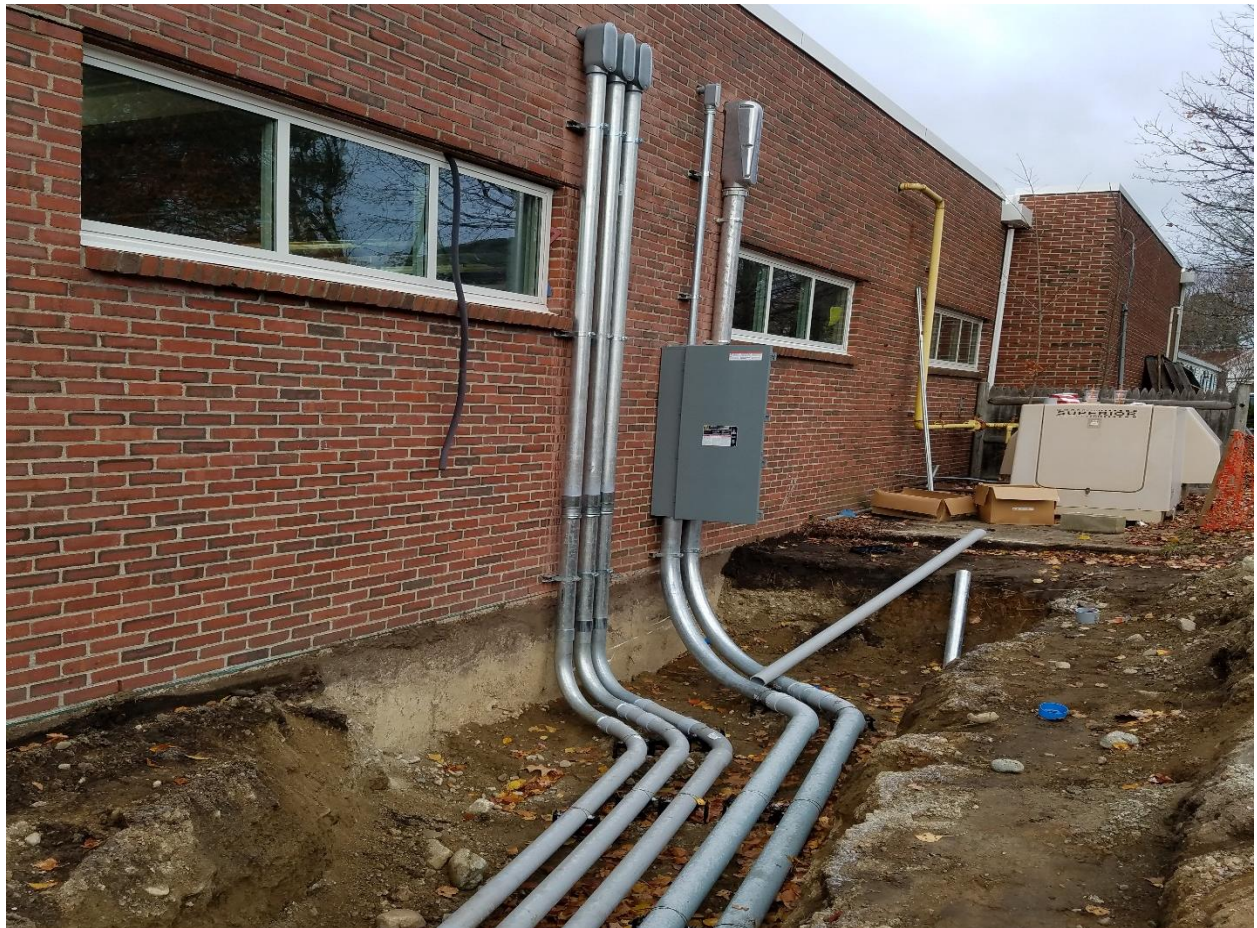
UNDERGROUND ELECTRICAL & COMMUNICATIONS DUCTBANK 11-18 -16

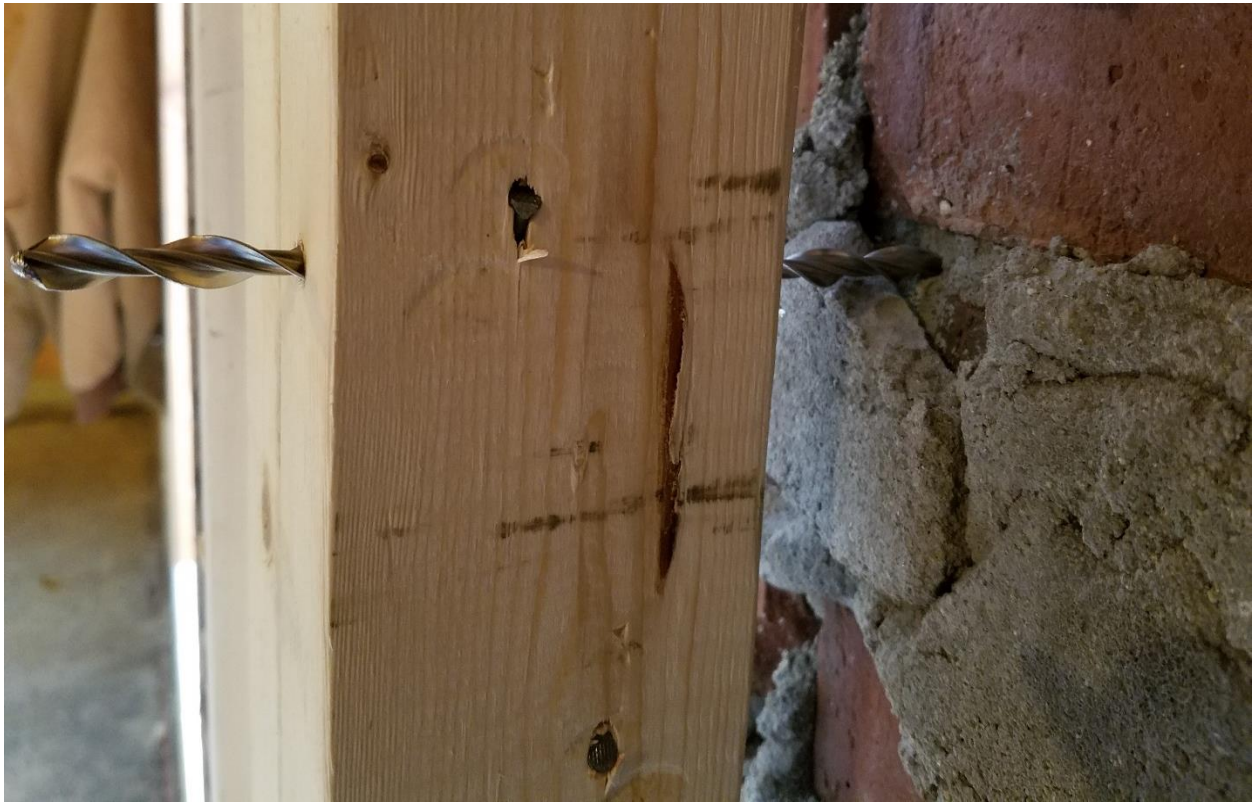
NEW SPIRAL BRICK TIES 11-15 -16

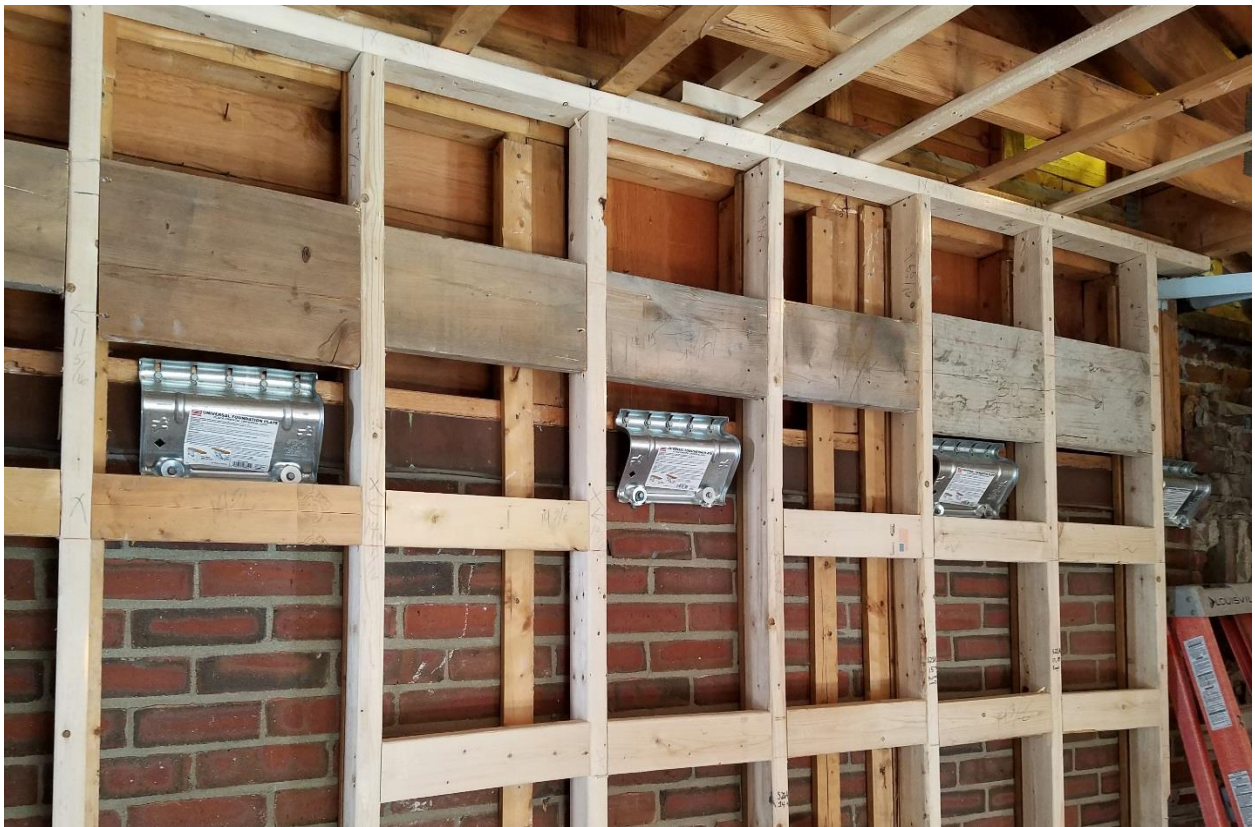
NEW MASONRY WALL-to- WOOD WALL ANCHORS 11-15 -16

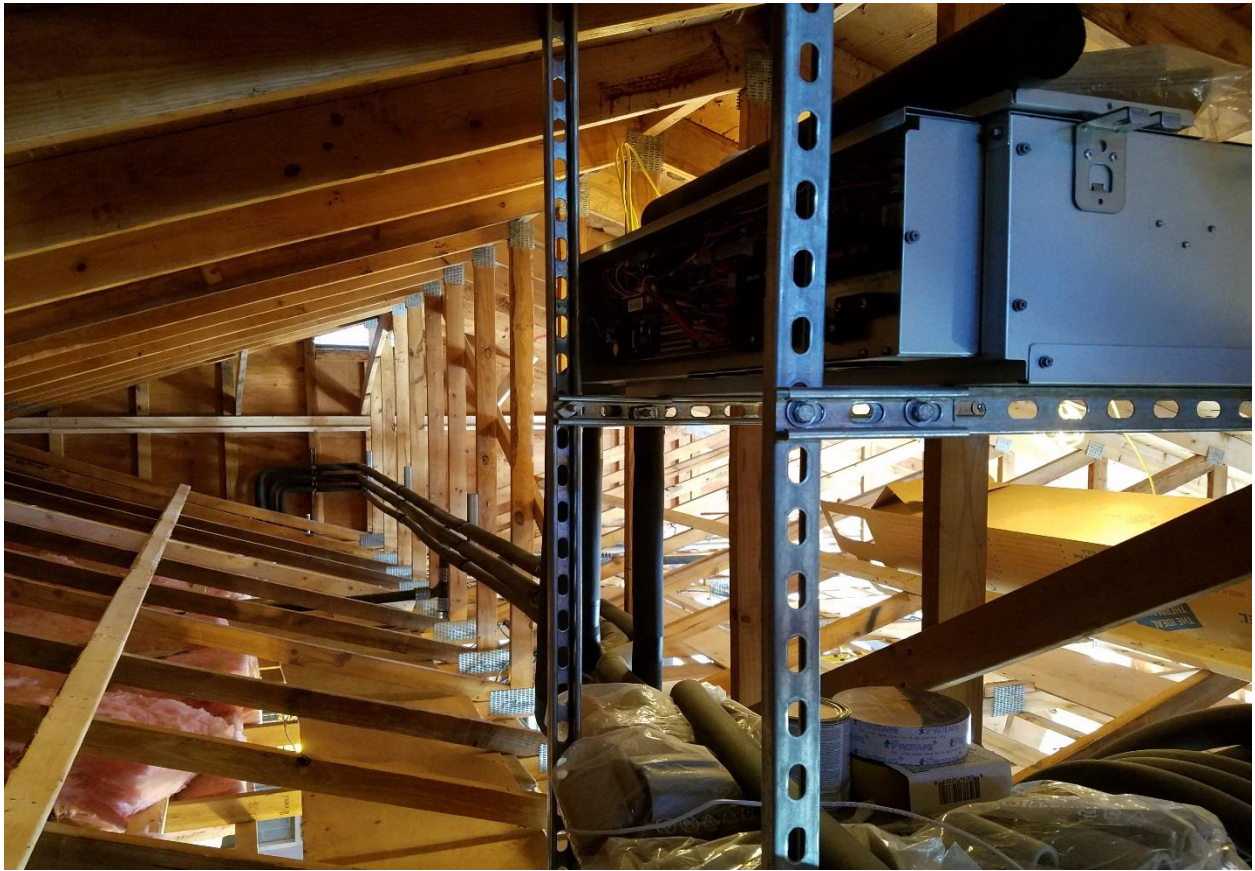
NEW ATTIC TRUSS BRACING & AHU INSTALLATION 11-16 -16

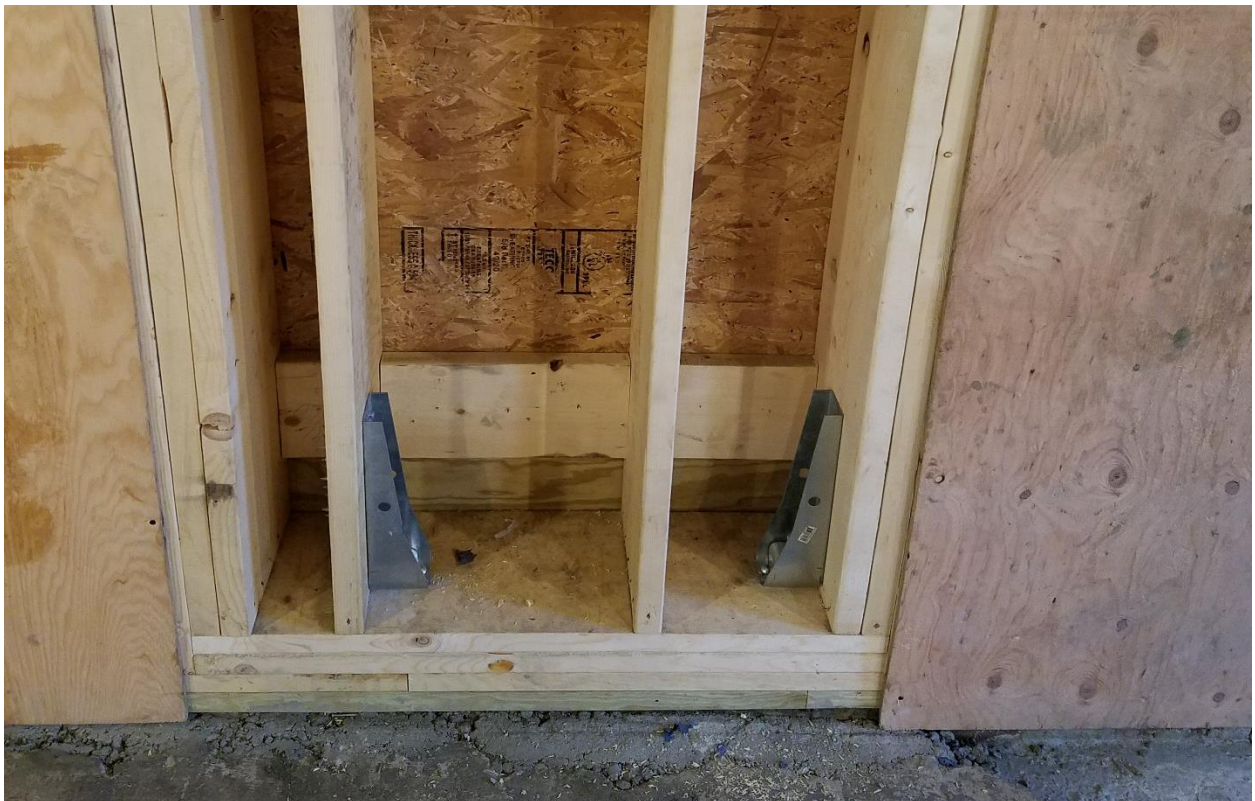
JACK STUD ANCHORS at FRONT WALL 11- 16 -16

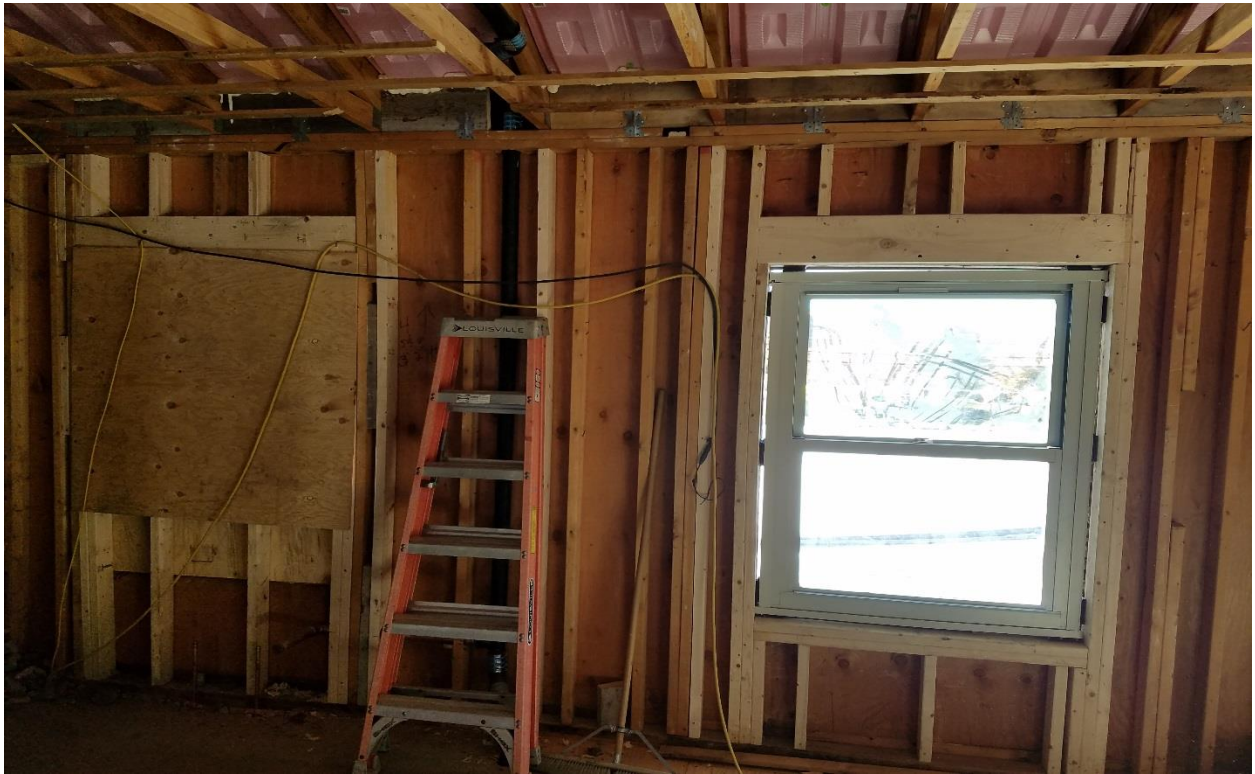
ADDITIONAL STUDS PLACED UNDER EACH TRUSS 11-16 -16

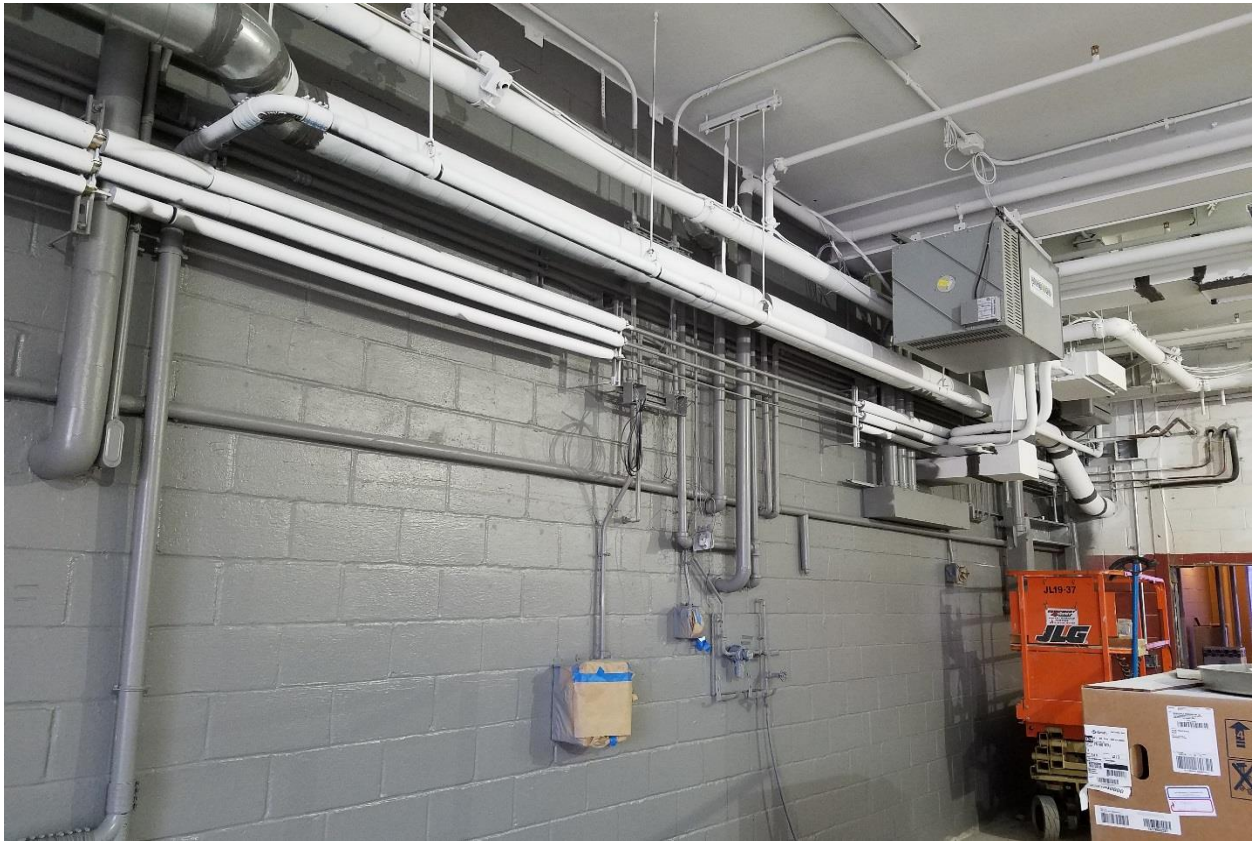
MECHANICAL PIPING IN APPARATUS BAY 11-16 -16

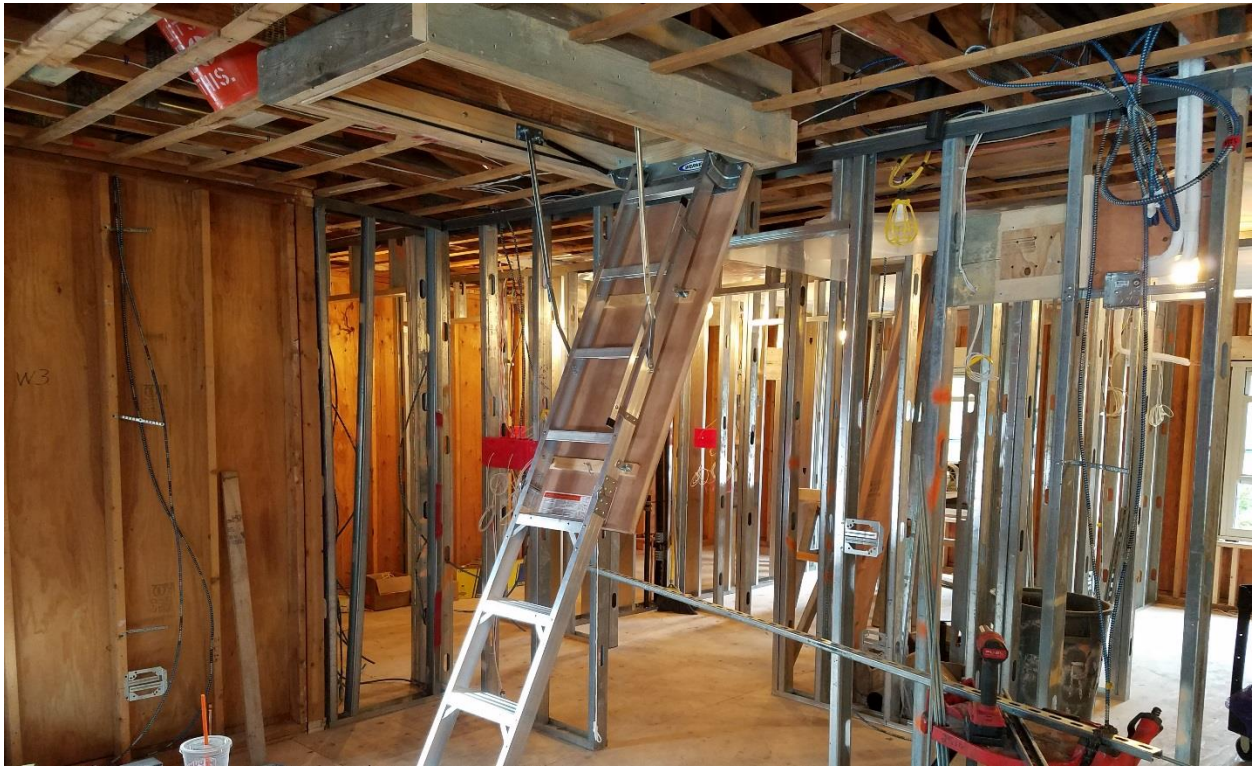
ATTIC ACCESS 11-20-16

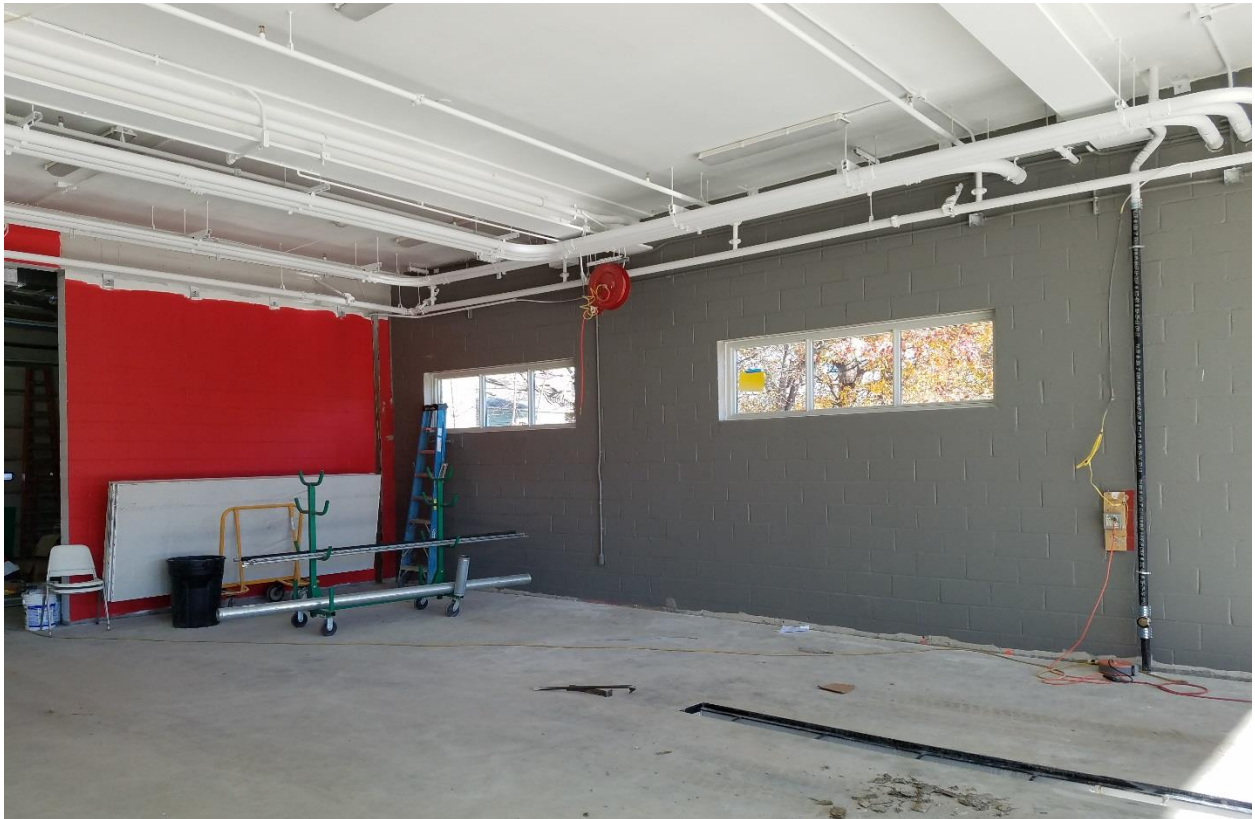
APPARATUS BAY PAINTED 11-18-16

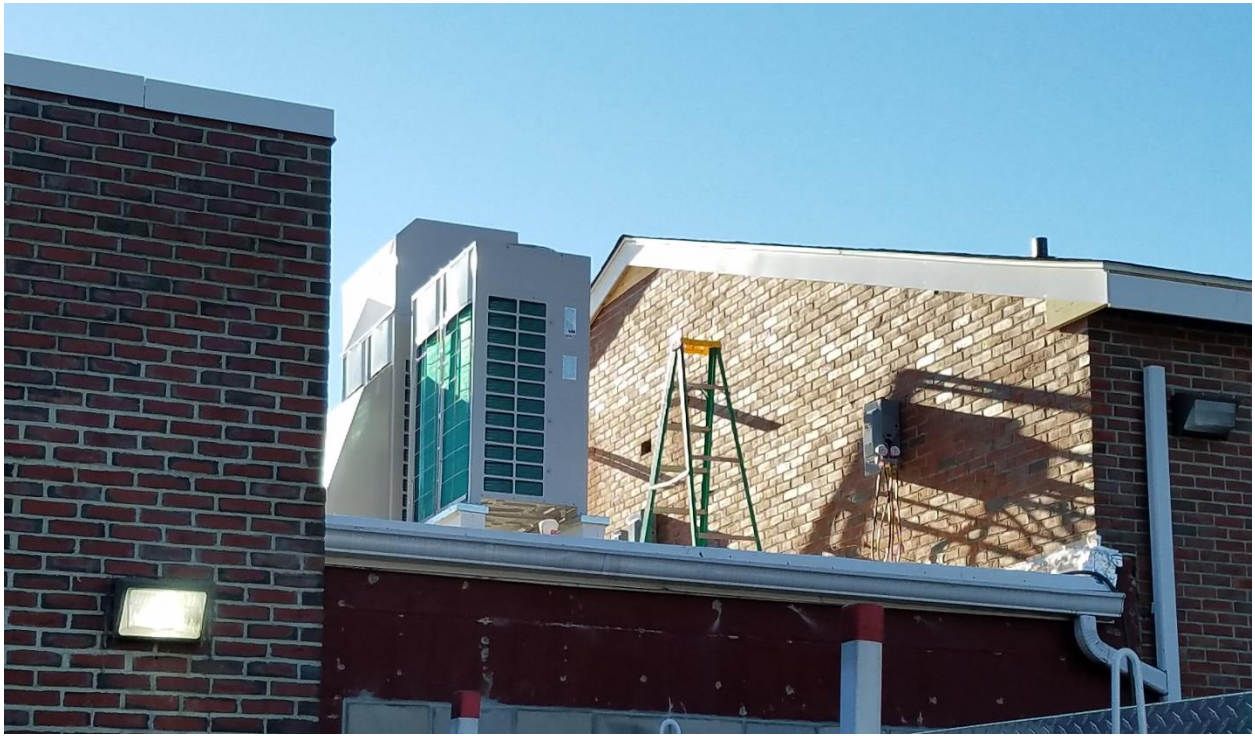
ROOF TOP UNIT SET as viewed from REAR showing NEW ROOF TRIM 11- 30 -16

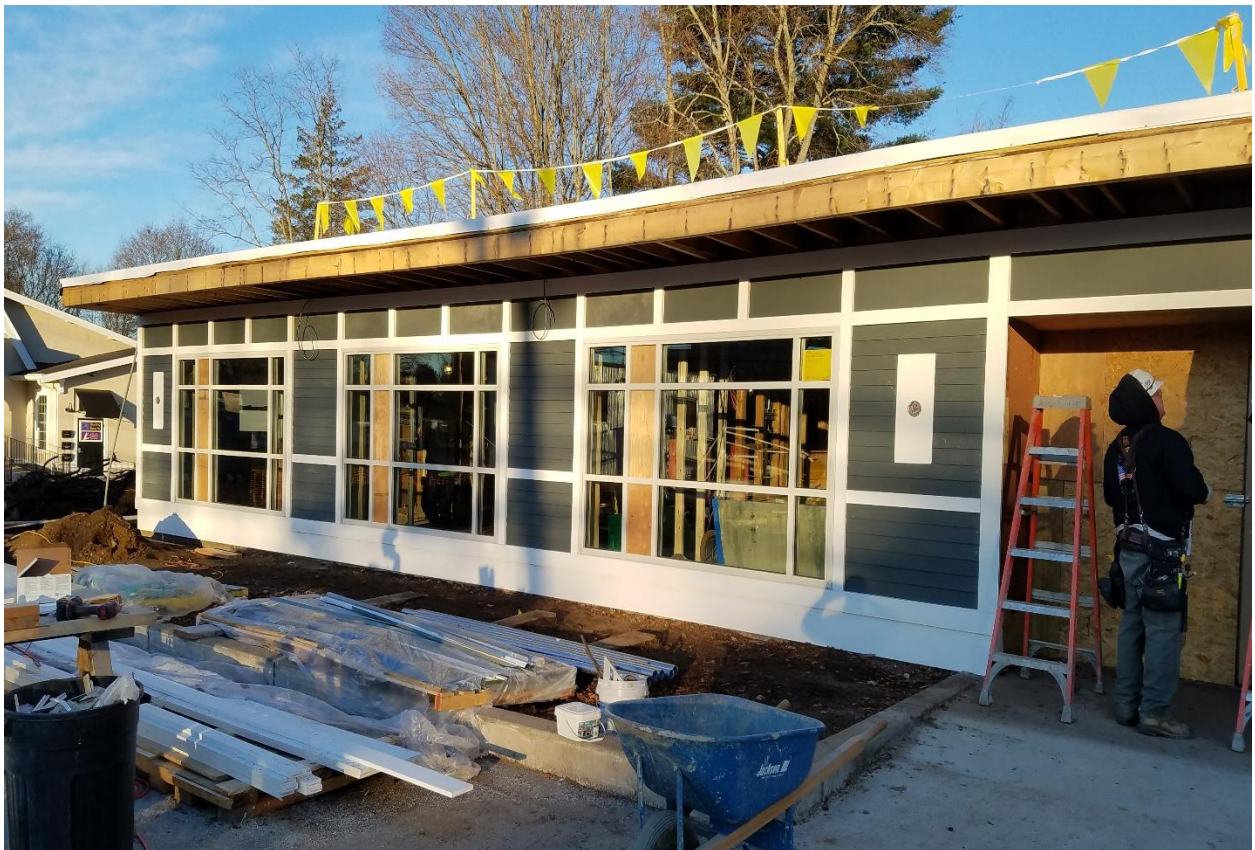
FRONT ELEVATION of ADMINISTRATION AREA 11-30-16
