# Town of Millis

## Police & Fire Station Project

MONTHLY PROGRESS REPORT

Report No.17

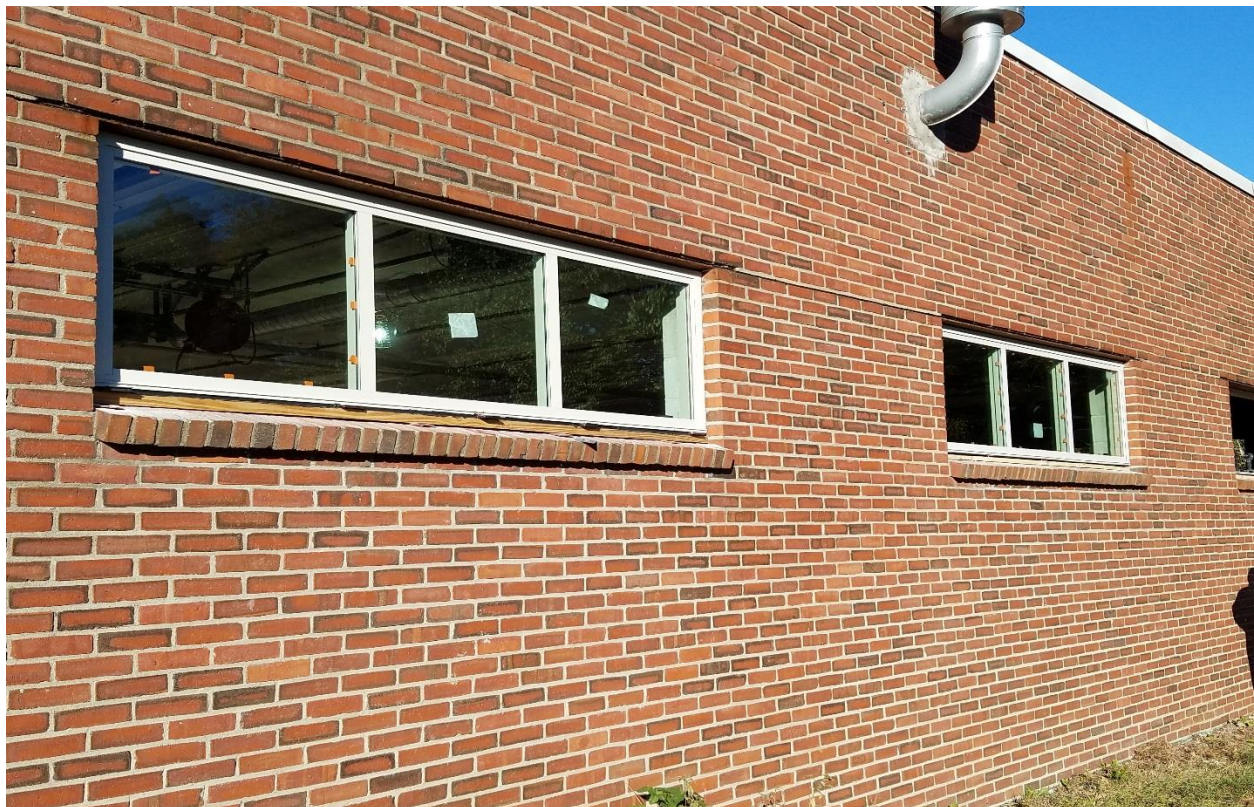
**NEW WINDOWS INSTALLED IN APPARATUS BAY AREA**

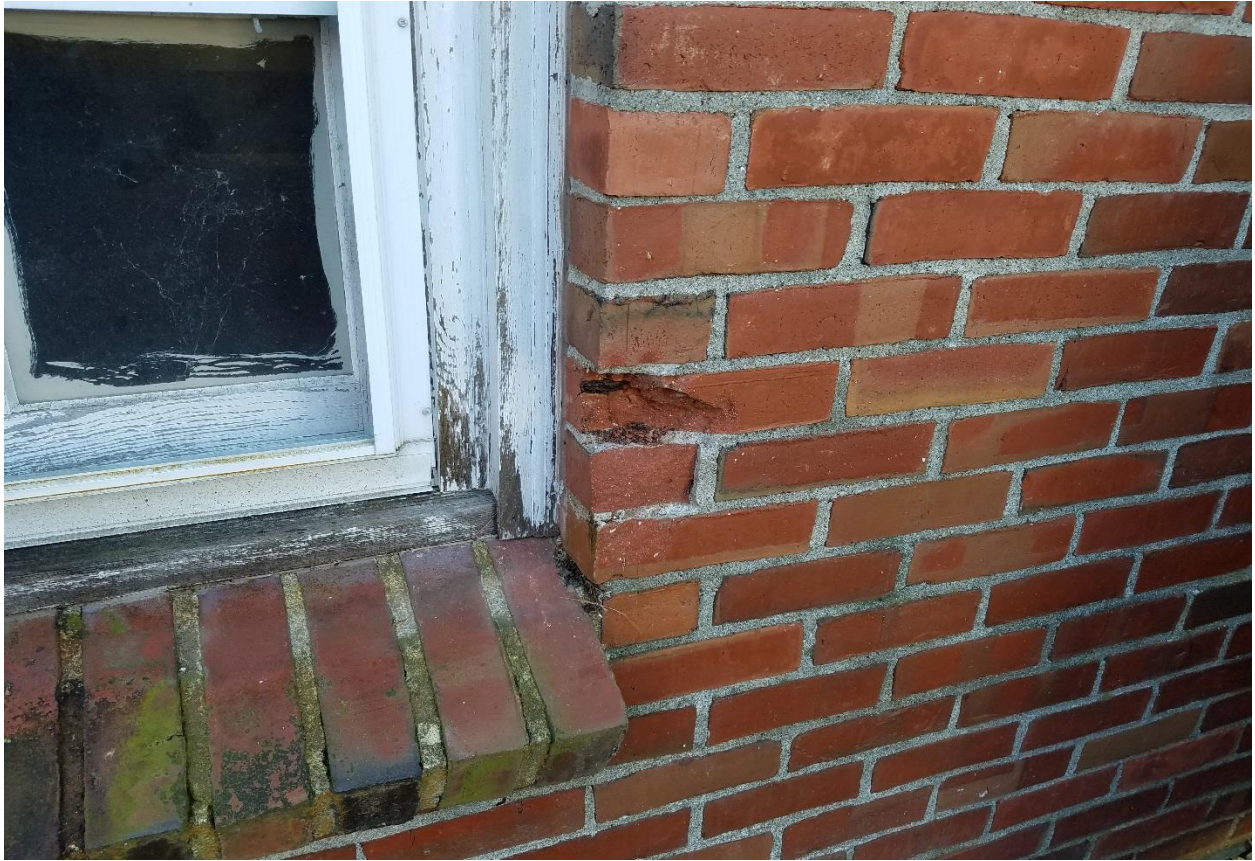
**EXISTING WOOD WINDOW TO REMAIN**

- Areas of exist exterior wood trim should be replaced due to dry rot.
- (4) Existing wood windows scheduled to remain should be replaced with new aluminum windows matching the others.

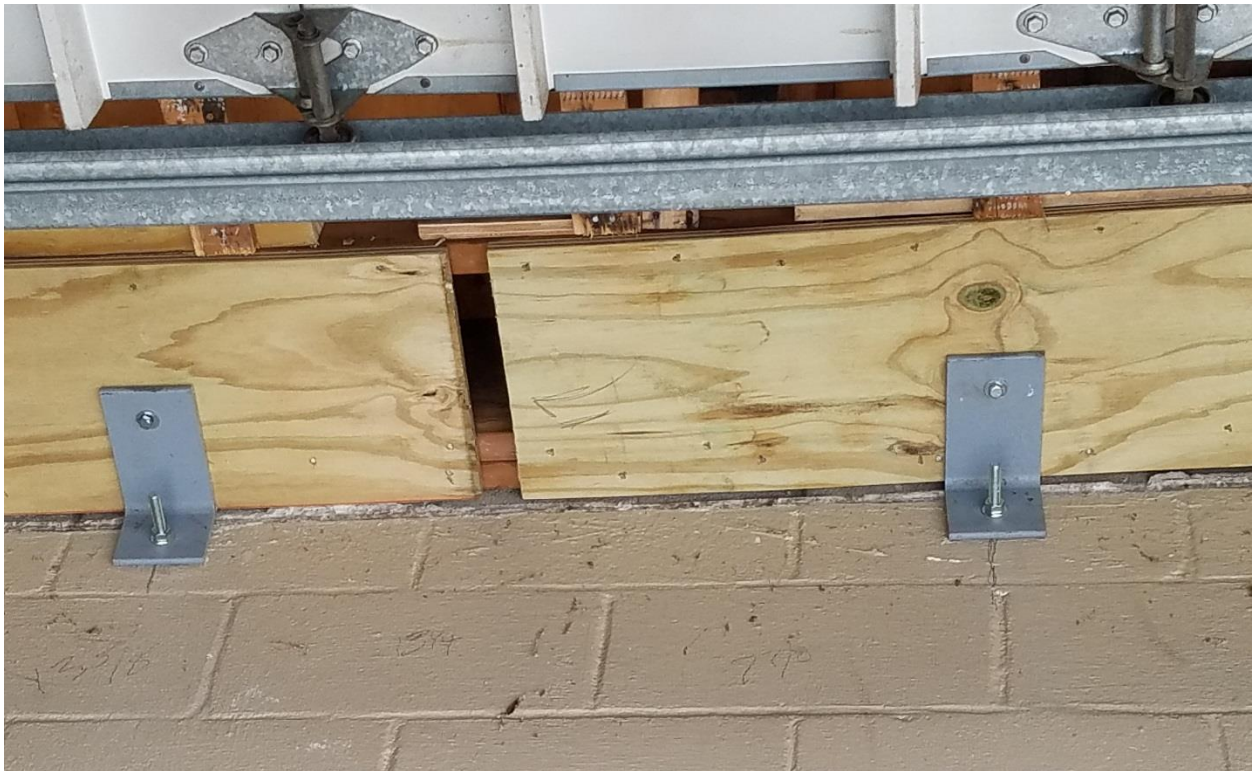
**SEISMIC CLIPS INSTALLED AT TOP OF MASONRY WALLS**

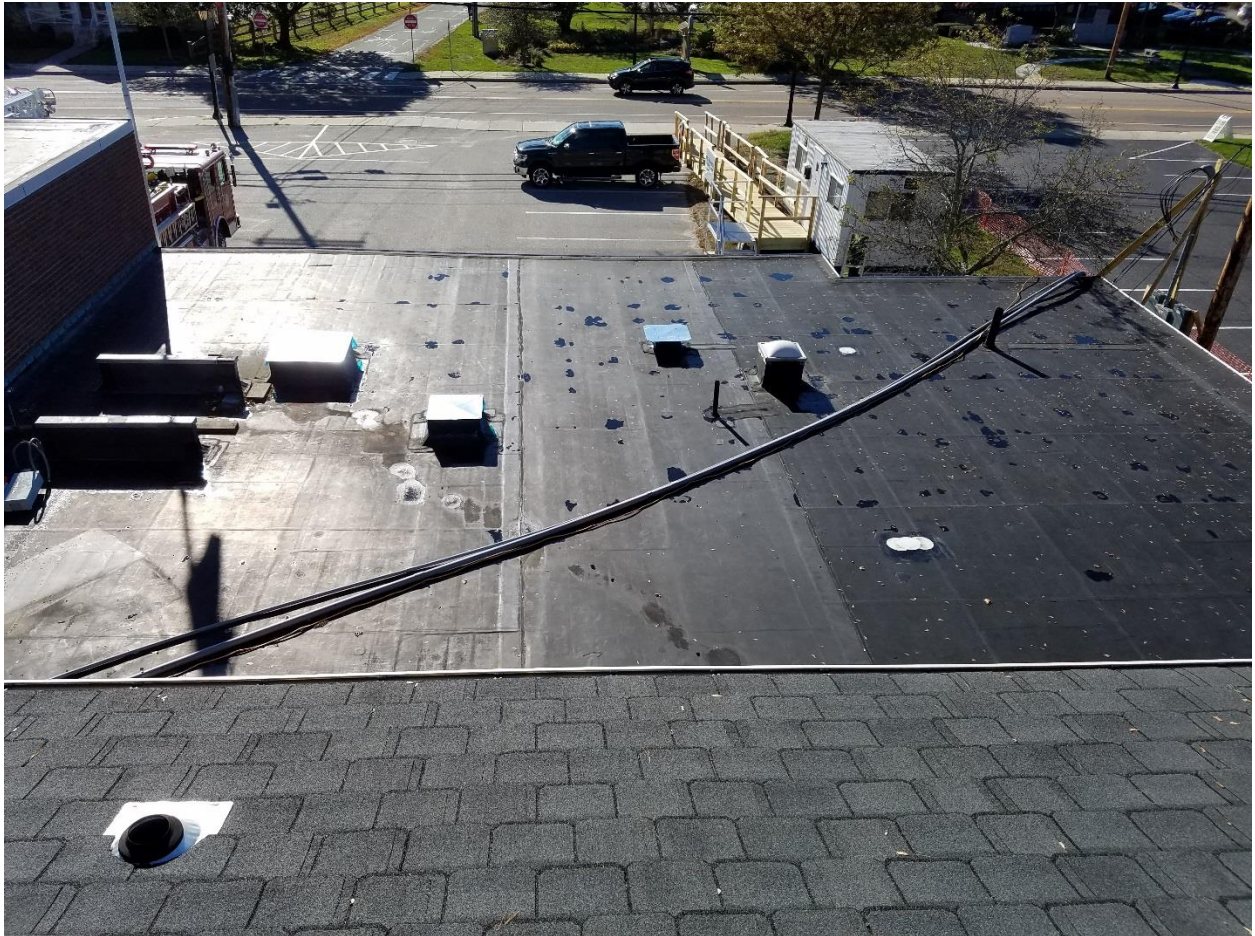
**ADMIN MEMBRANE ROOF AREA TO BE REPLACED AS PART OF BASE BID**

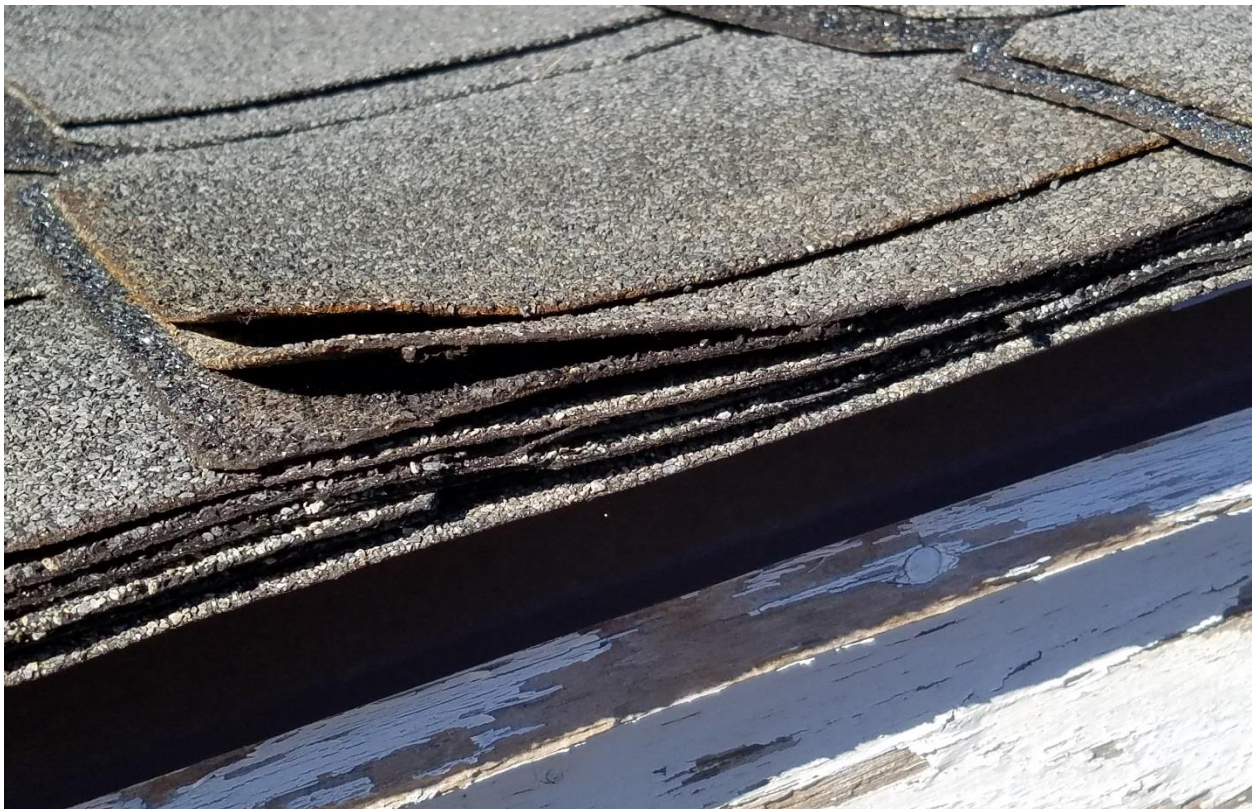
- Existing exterior walls & ceiling not specified to be re-insulated
- Existing Attic may not have sufficient access or ventilation
- Existing shingled roof may need repairs

**EXISTING MULTI-LAYERED SHINGLED ROOF SCHEDULED TO REMAIN**

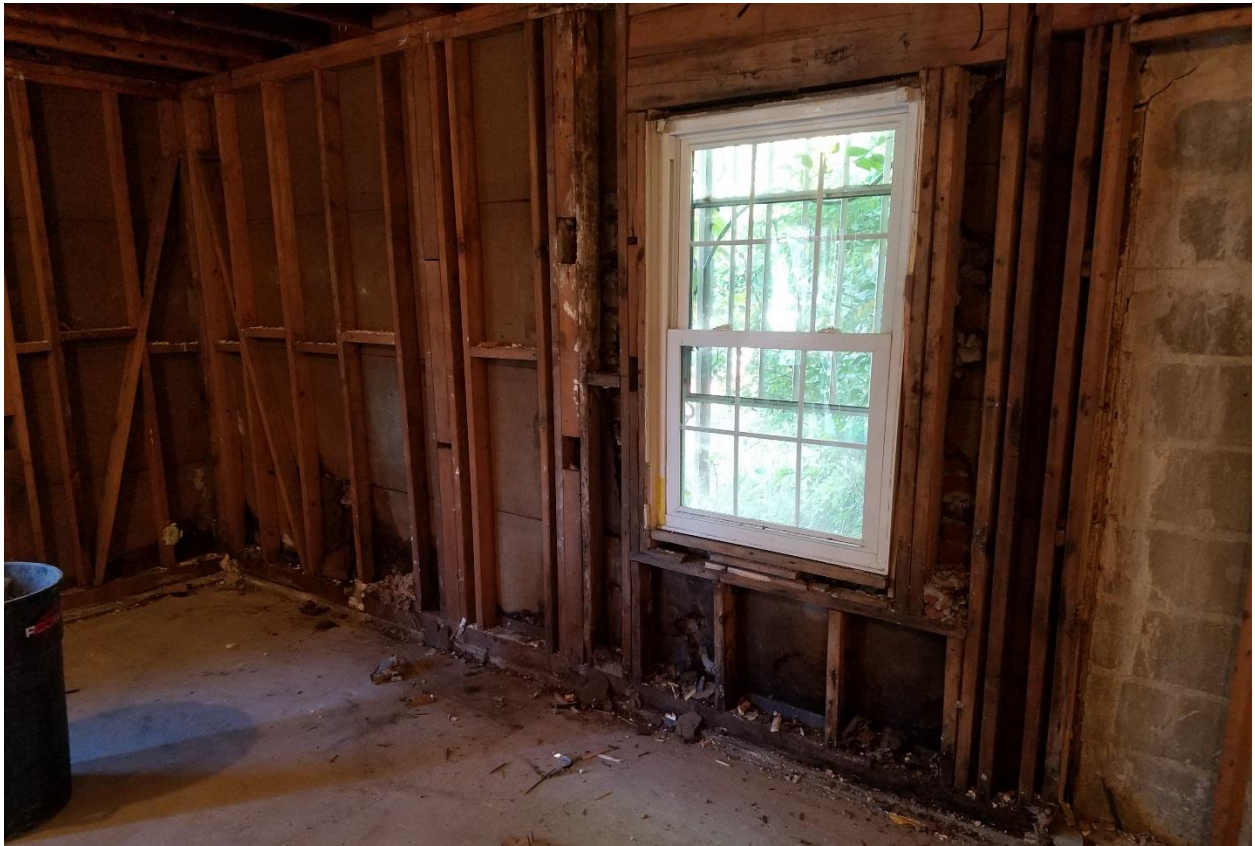
- The concern over possible structural damage reported last report has now been revealed and evaluated by the Structural Engineer. Remedial work to exterior wall studs & sheathing and existing roof trusses will need to be addressed via upcoming ASI and sketches.

**AREAS OF WATER-DAMAGED WOOD FRAMING**

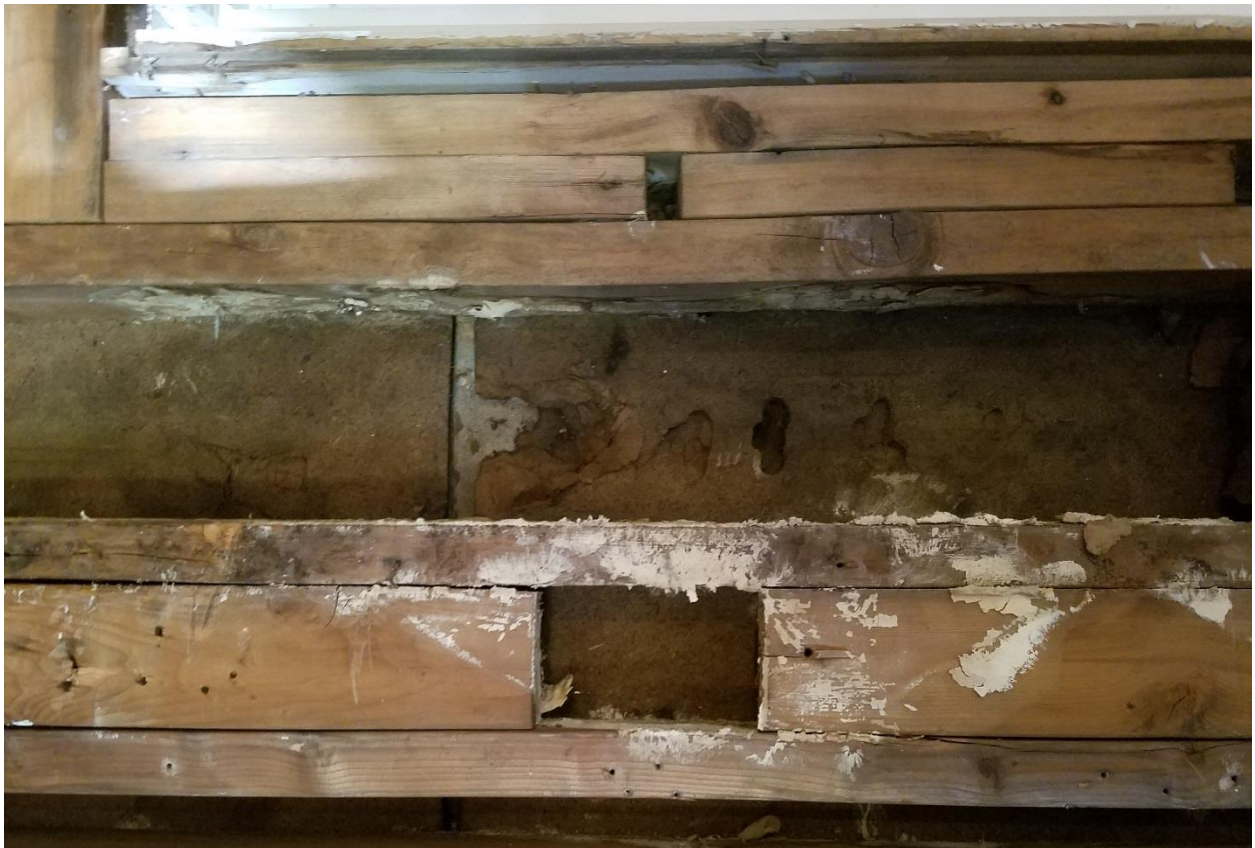
**ADDITIONAL AREAS OF ROT & MOLD DAMAGED WOOD FRAMING**

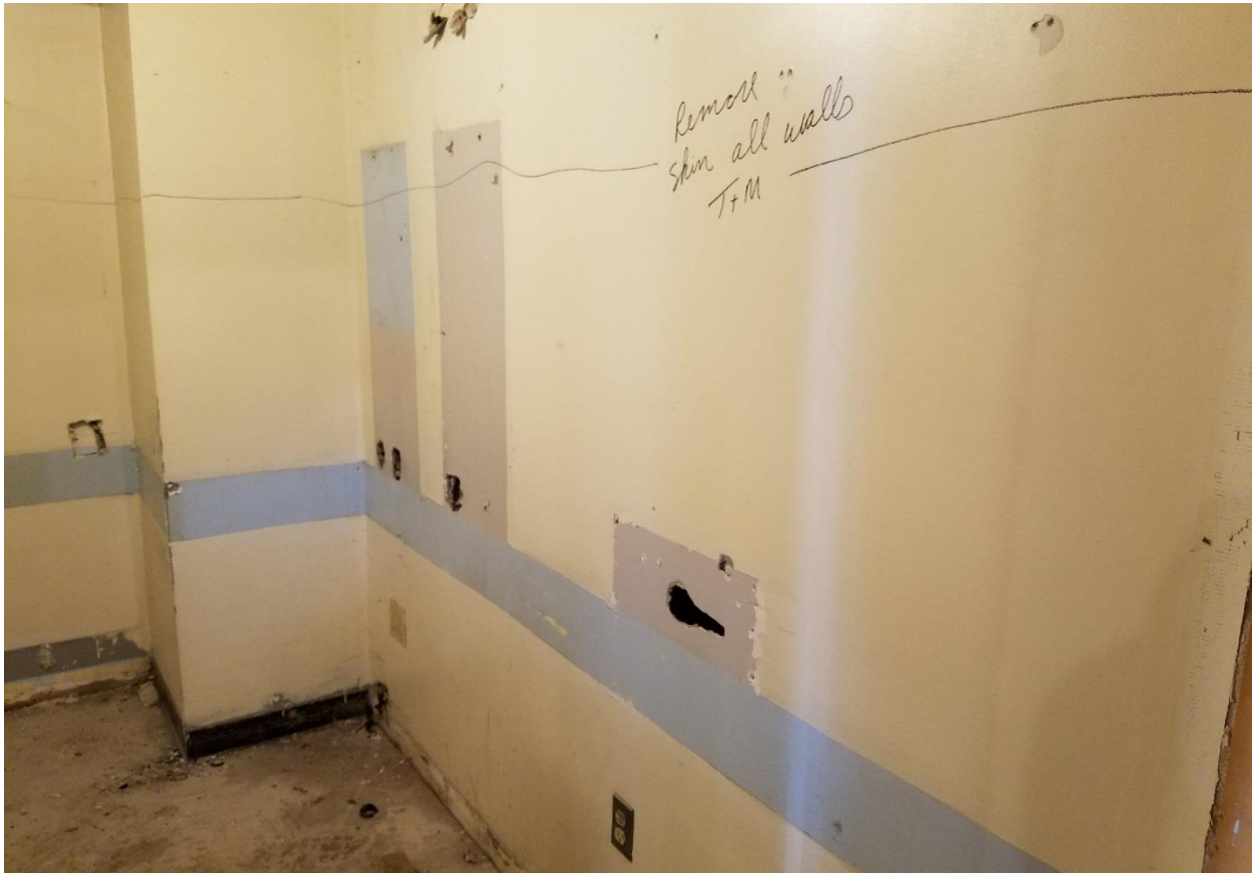
**EXISTING SHEETROCK NEEDING DEMOLITION FOR NEW WORK**

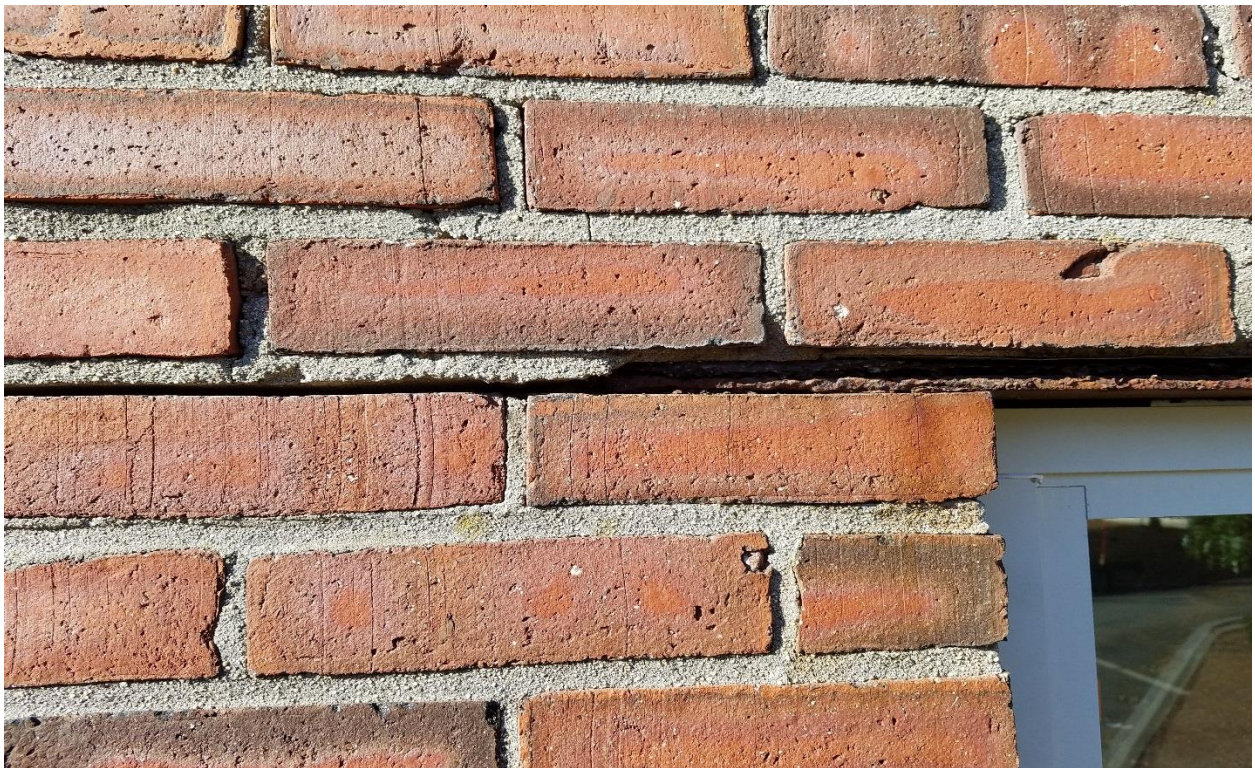
- Portions of exterior masonry need remedial work as identified in a survey performed by the Millis PM. Work could include re-pointing, installation of control joints, certain bricks replaced, multiple existing metal fasteners removed, etc.

**MASONRY JOINTS NEEDING RE-POINTING**

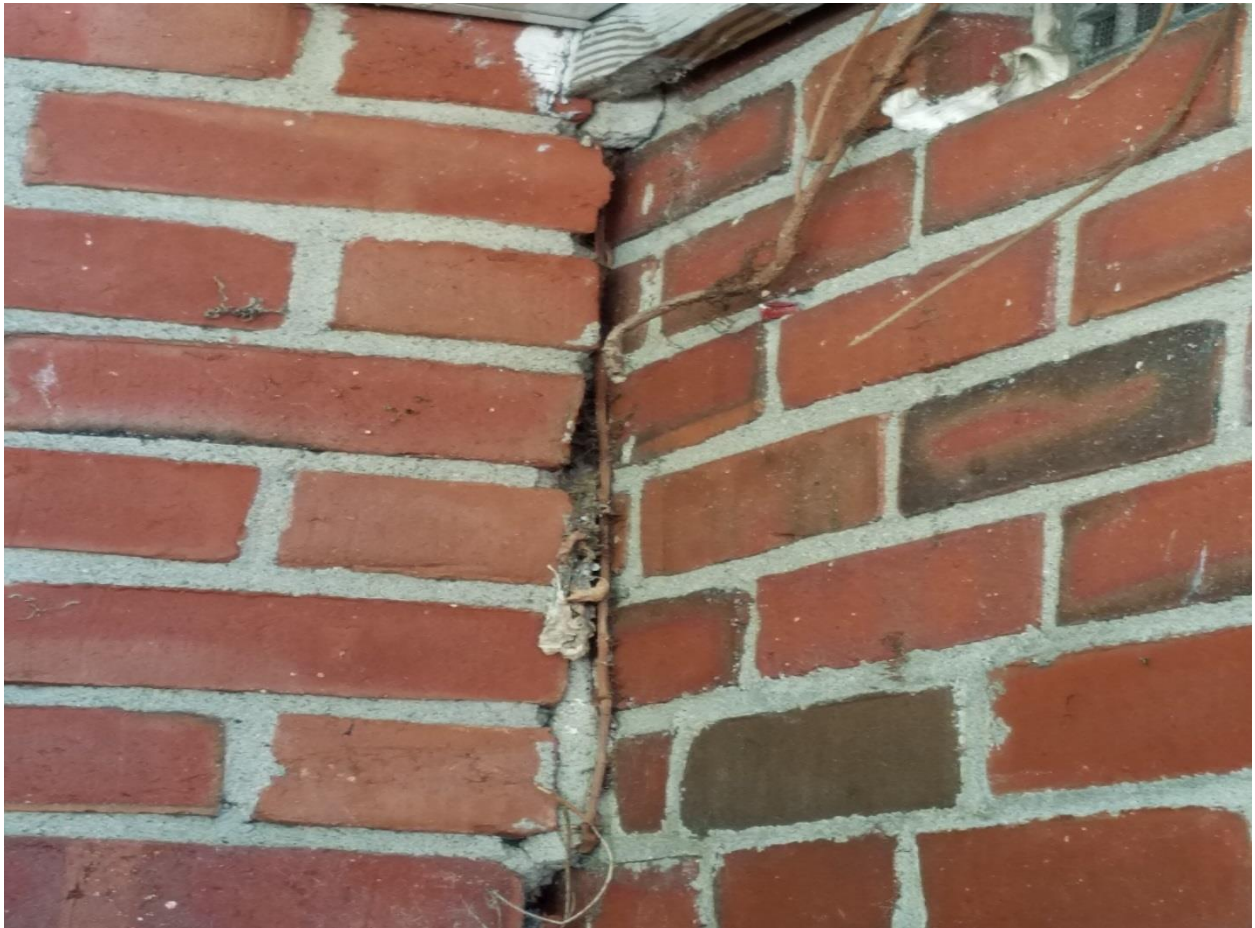
**MASONRY NEEDING REWORK AND INSTALLATION OF CONTROL JOINT**

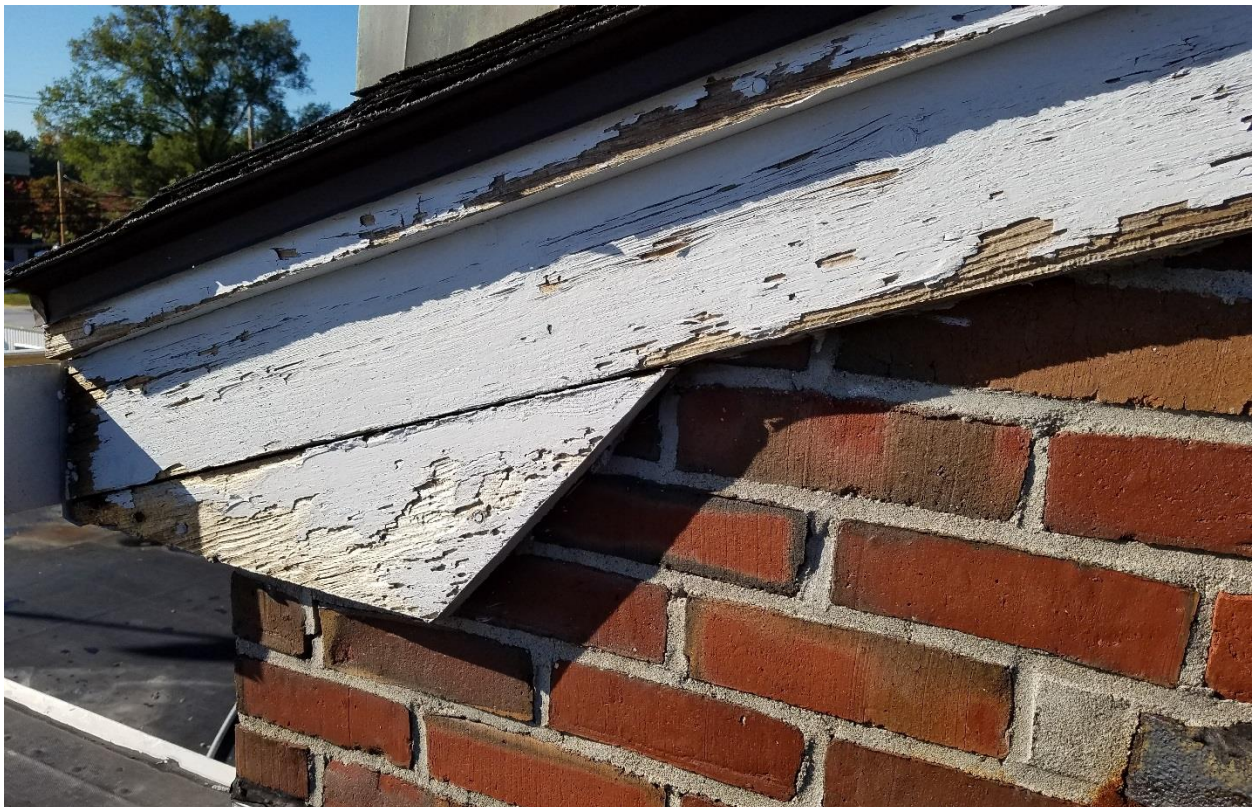
**DRY-ROTTED WOOD TRIM SCHEDULED TO REMAIN**
