# Town of Millis

## Police & Fire Station Project

### MONTHLY PROGRESS REPORT

Report No. 4

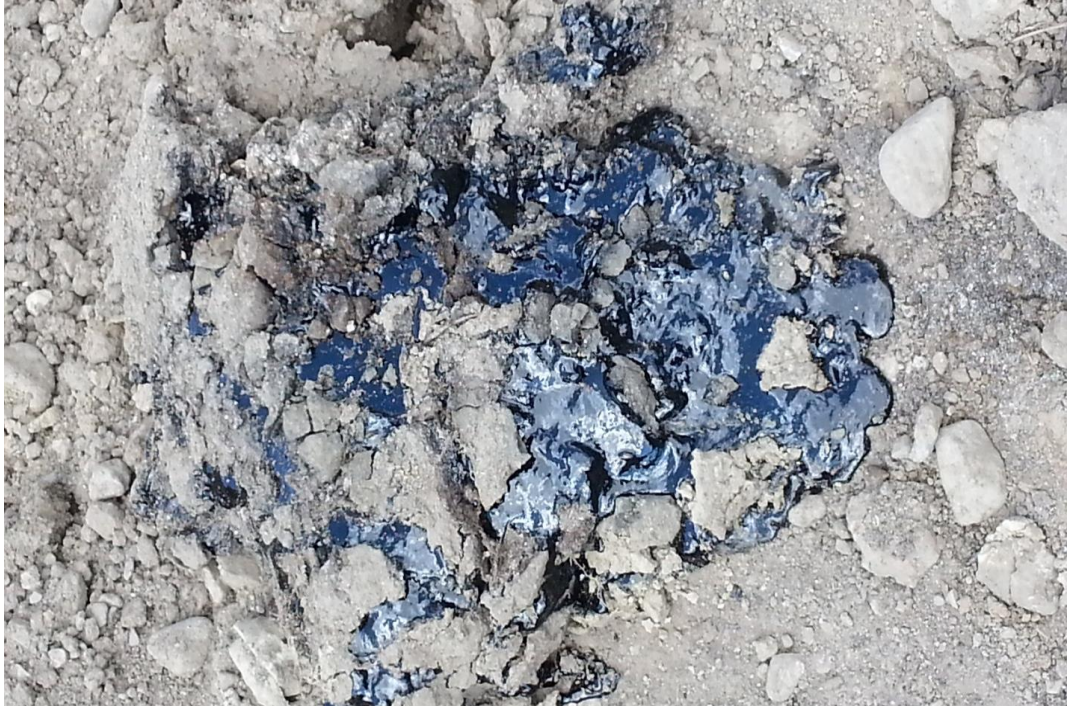
- Also during footing excavations, chunks of asphalt built-up roofing debris and roofing tar was discovered in the SE corner of the site. These materials tested NEGATIVE for PCB's and lead and but positive for petroleum content. Because of strong petroleum odors observed in the underlying layer beneath this debris, that soil was tested for contamination ( similar to the already known contaminated soils removed as part of Contract work ). Sovereign Consulting, the project's environmental consultant & LSP, has been authorized to seek permits for the removal and disposal of these contaminants.

**OIL GLOBULES INTERMIXED IN SOIL 9-1-15**

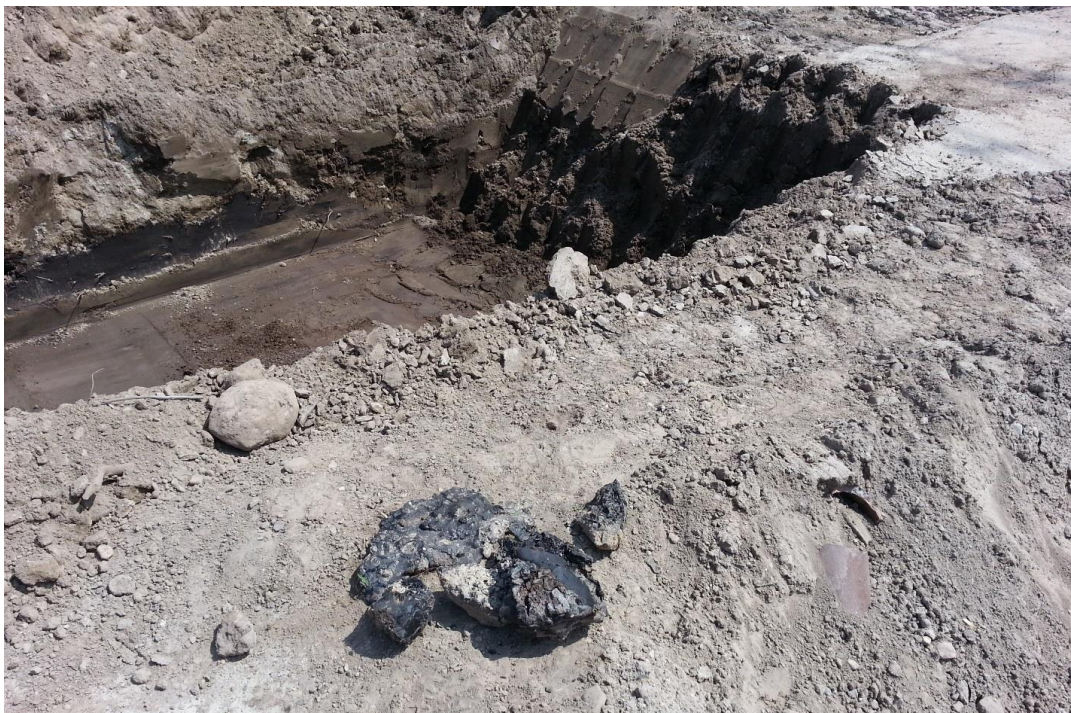
**ORGANIC LAYER VISIBLE IN SIDEWALL OF FOOTING EXCAVATION  
WITH OIL GLOBULE IN FORGROUND 9-1-15**

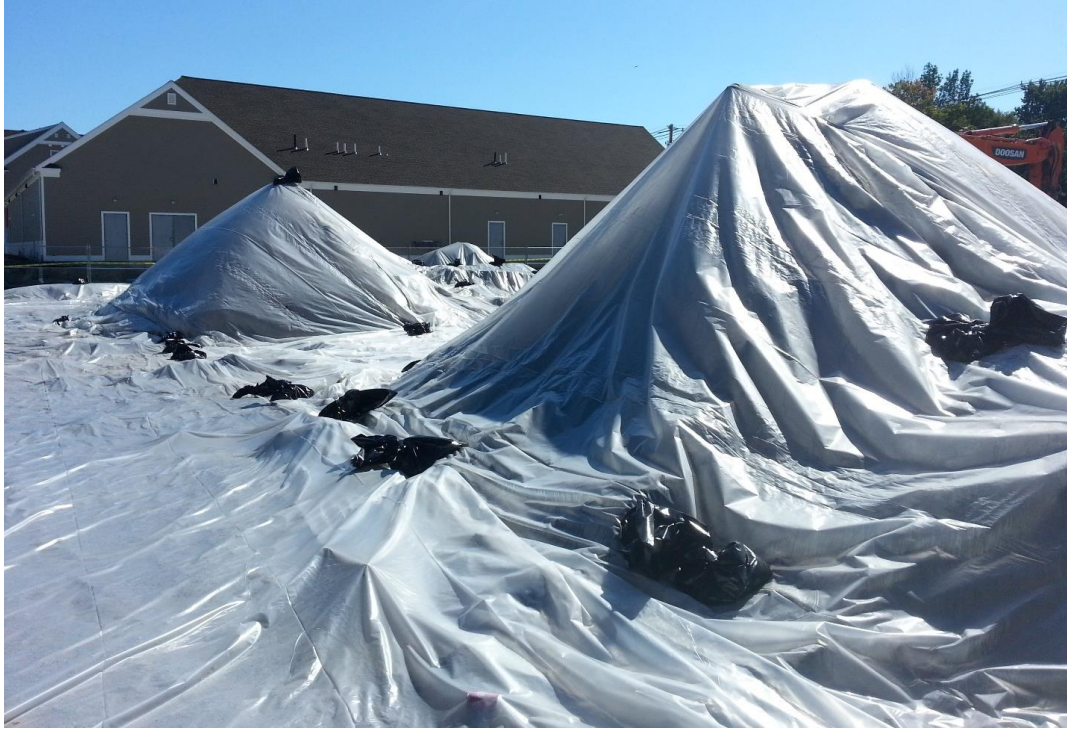
- The footing excavation work started last month has now revealed some additional unforeseen subsurface conditions beyond the organic layer reported last month. Some of the excavated materials tested found asbestos present in the form of cement shingle debris, transite pipe fragments and friable debris. Axiom Partners, the project's asbestos consultant has been engaged to make application to the DEP for abating the contaminated soils. A work plan has been submitted to DEP describing the removal and disposal process being proposed as well as personnel monitoring of the workers and air quality testing at the perimeter. As a precaution, the entire site has been protected by a polyethylene covering that will remain in place until the approved activities can begin.

**POLYETHYLENE COVERING STOCKPILES 9-15-15**

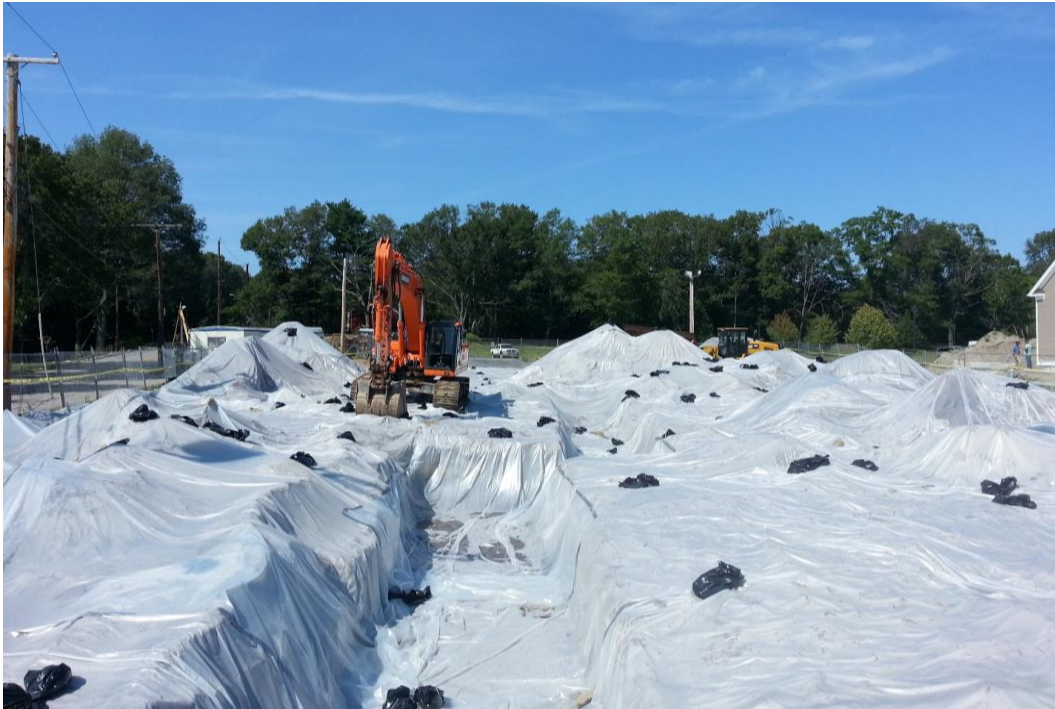
- With the discovery of suspected contaminated soils work was suspended on September 2<sup>nd</sup>. The sitework equipment currently on site has been quarantined and as a result accruing an “idle equipment charge” of \$1500/day until such time the approved clean-up work can begin, and this equipment cleaned by asbestos workers allowing removal from site.

**POLYETHYLENE COVERING ALL EXCAVATIONS  
WITH QUARANTINED EQUIPMENT 9-15-15**
