Spencer, Sullivan & Vogt
ARCHITECTURE • PRESERVATION

Conditions Assessment & Feasibility Study for the
LANSING MILLIS MEMORIAL BUILDING

64 EXCHANGE STREET, MILLIS, MASSACHUSETTS • 1 FEBRUARY 2021

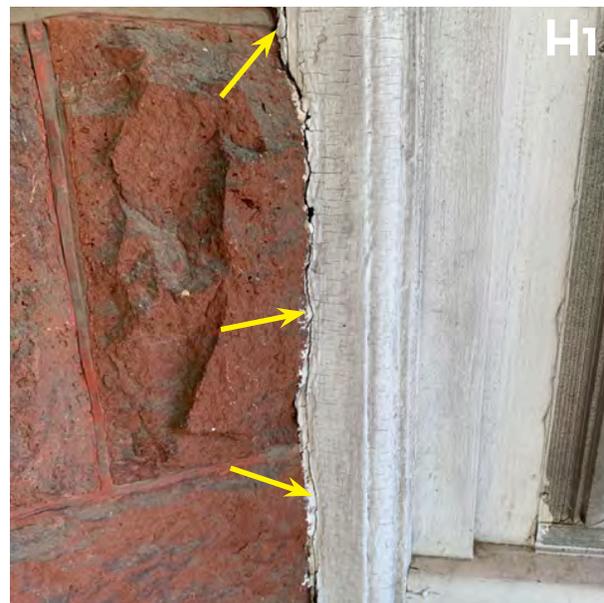
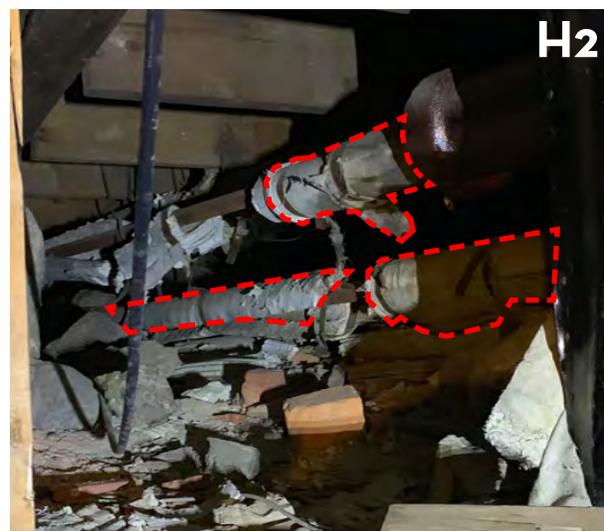
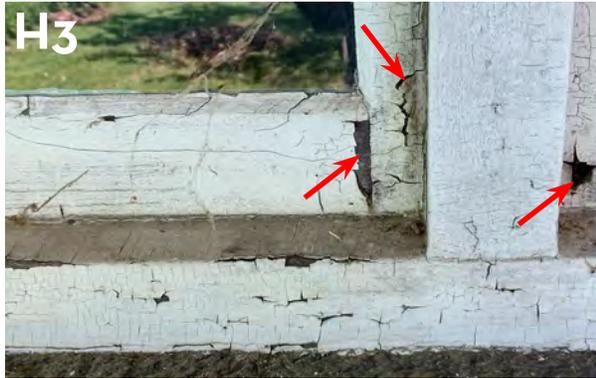
- At the exterior, asbestos is typically found in adhesives, glazing putties, caulking (see Img. H1), and roofing cement dating to the 20th century. As such, all windows should be tested for asbestos before their removal. Any mastics appearing red or black in color should also be tested. In the event that asbestos is detected, it should be properly abated by trained professionals as part of the construction process.

- At the interior, asbestos was often used for fireproofing and insulation, but could also be found in caulking. Heating pipes in the basement crawl space are wrapped in material in which asbestos is frequently found (see Img. H2). Given the presence of non-original partitions within the structure, it should also be noted that asbestos-containing skim coats and joint compounds were used in wallboard construction. To test both would be good practice, and any incidence of the material should be similarly abated.

problems over time. Lead paint was builders' paint of choice for centuries, valued for its durability and vibrancy. It is therefore very likely that the Lansing Millis Memorial Building contains the material (see Img. H3). All interior and exterior paints should be tested for lead. If lead is present, regulated lead management practices should be followed in handling and disposing of painted materials, and in preparations for recoating. For some potential occupancies where young children will be the present, the lead must be abated.

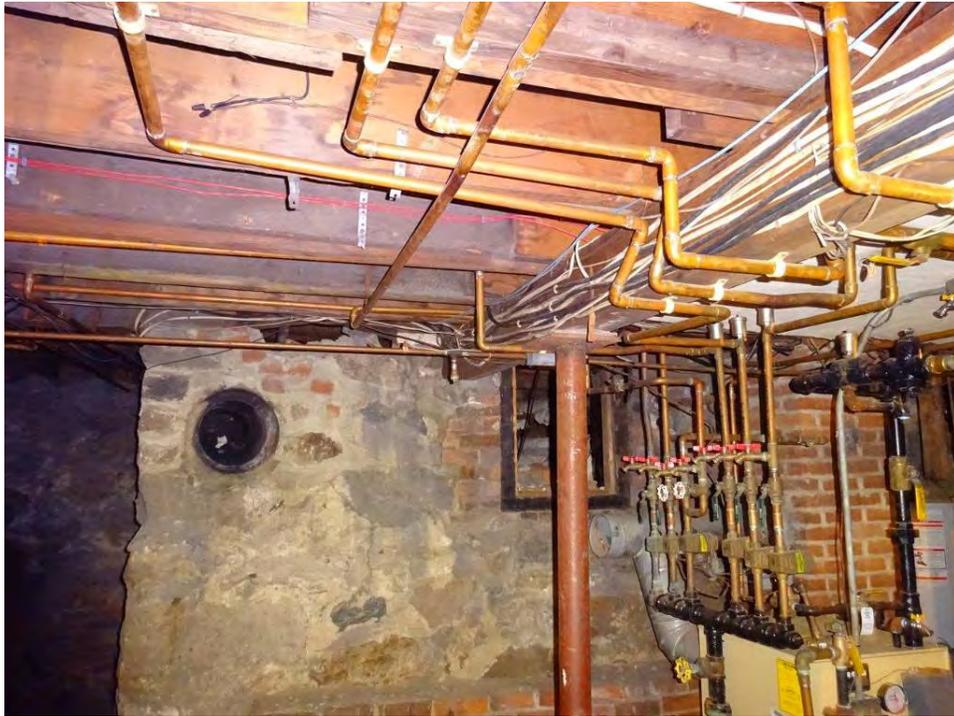
Photo 1
Basement facing crawlspace to the east

Approximately two-thirds of the building has a full basement at its west end, and a crawlspace is located at the east portion (see Photo #1 on Page 1 of the Appendix). The floor and roof framing consists of lumber joists that generally span north-south and are supported at their exterior ends by stone masonry perimeter walls. There is an interior beam at the approximate middle of the first floor that spans east-west, and the first floor wall above is likely a bearing wall for the second floor framing.

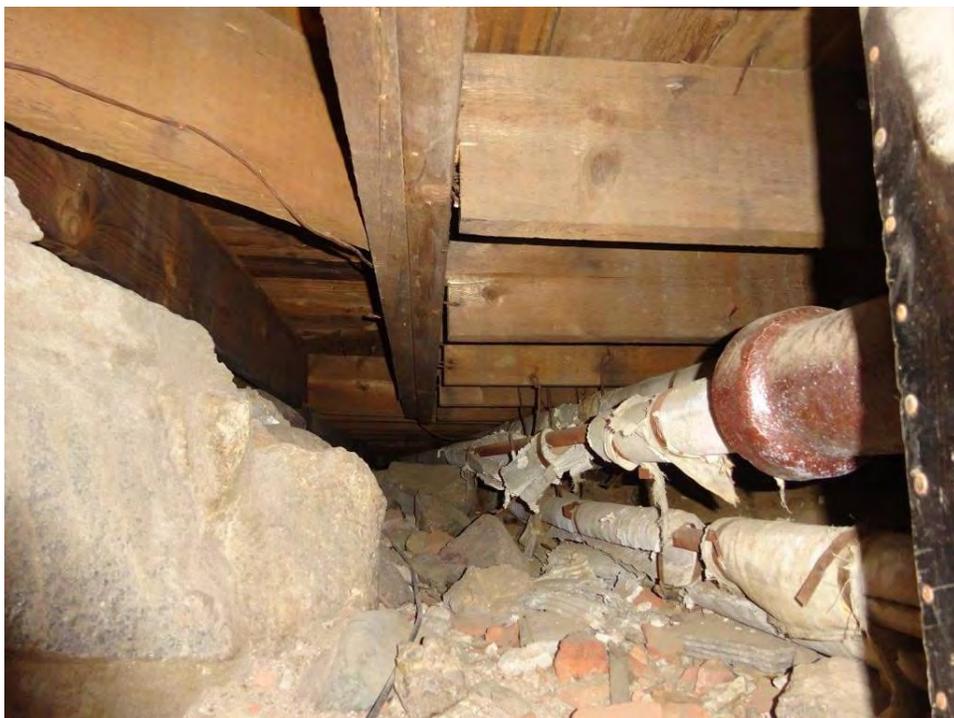
- F1** Several flush-framed conditions at the first floor either have no hangers or have hangers that are improperly installed (see Photos #2 through #4 and #6 on Pages 1-3 of the Appendix). Several of these locations have separated or are susceptible to splitting.

Photo 2
Visible portions of the first floor framing at crawlspace (facing east)

- Though none of the anticipated changes would *increase* the current loading, some conditions require further investigation.
- Several flush-framed conditions at the first floor require additional support, which can be provided through installation of new metal face-mount hangers.

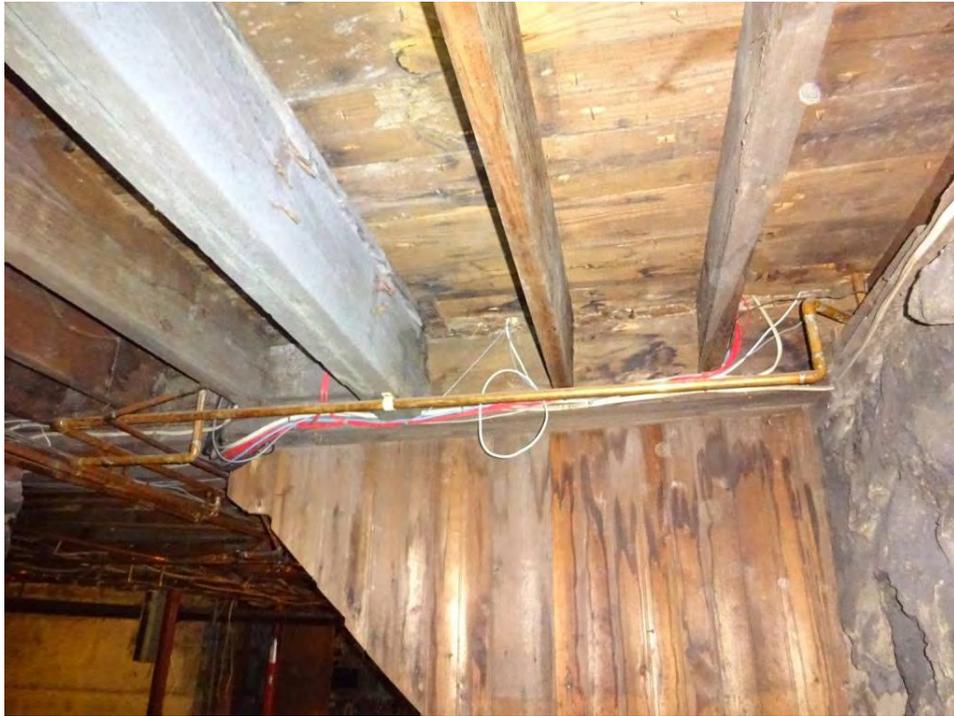
Photo 3
East edge of first floor stair header (facing west)

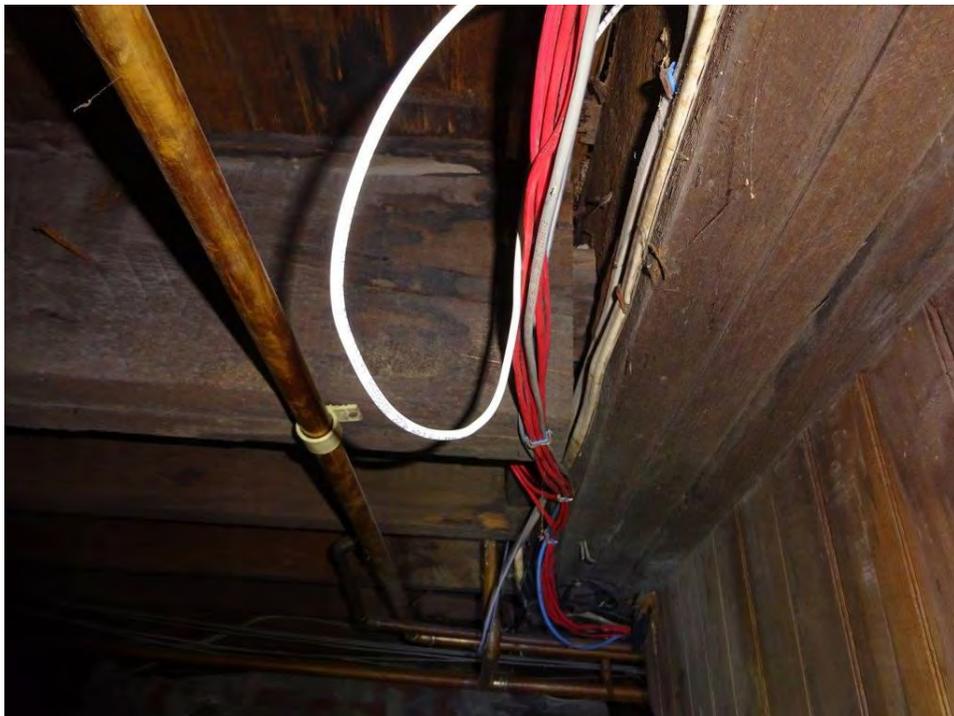
Photo 4
First floor stair framing at stair header, showing notched cog (facing south)

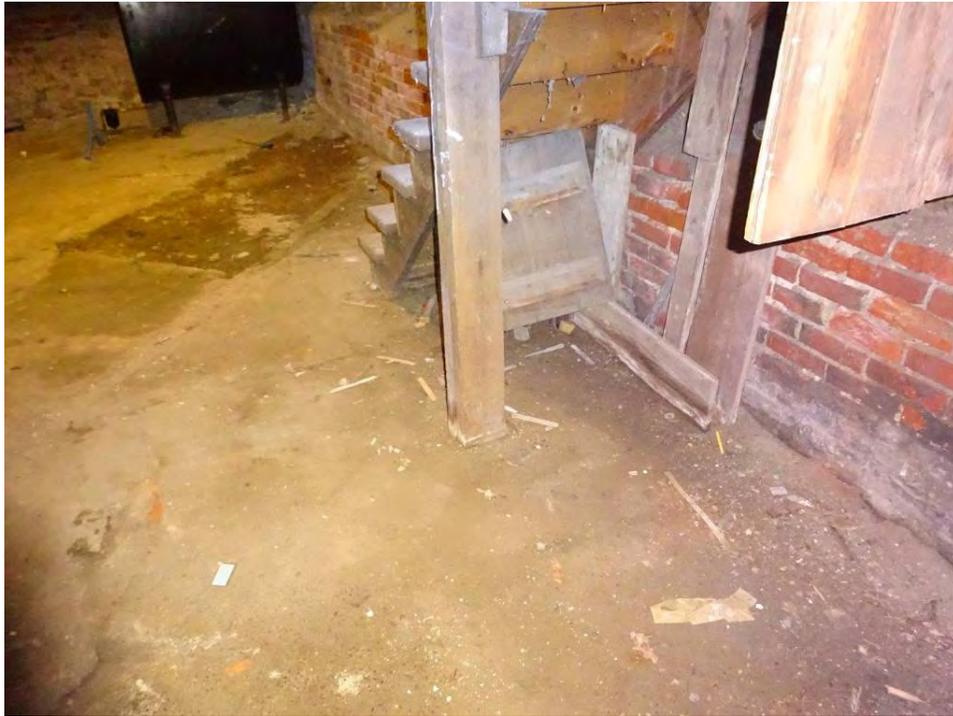
Photo 5
Wood post at corner of basement stair

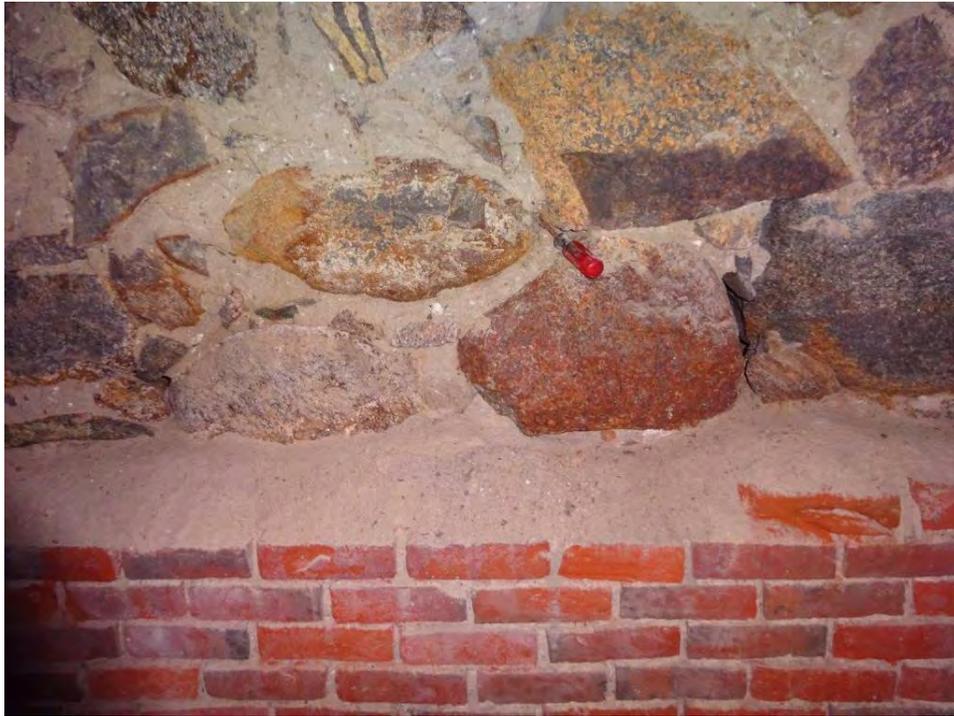
- M1** The bottom portion of the foundation wall that consists of brick masonry where the joints have eroded (see Photo #7 on Page 4 of the Appendix).

M2 Similar to the brick portion, the stone portion above the brick has mortar joints that have eroded below grade. This damage is more severe as the joints in the stone are much larger and the soil behind the stones has likely begun to subside, resulting in large voids in the wall (see Photo #7 on Page 4 of the Appendix).

Photo 7
Interior face of stone foundation wall

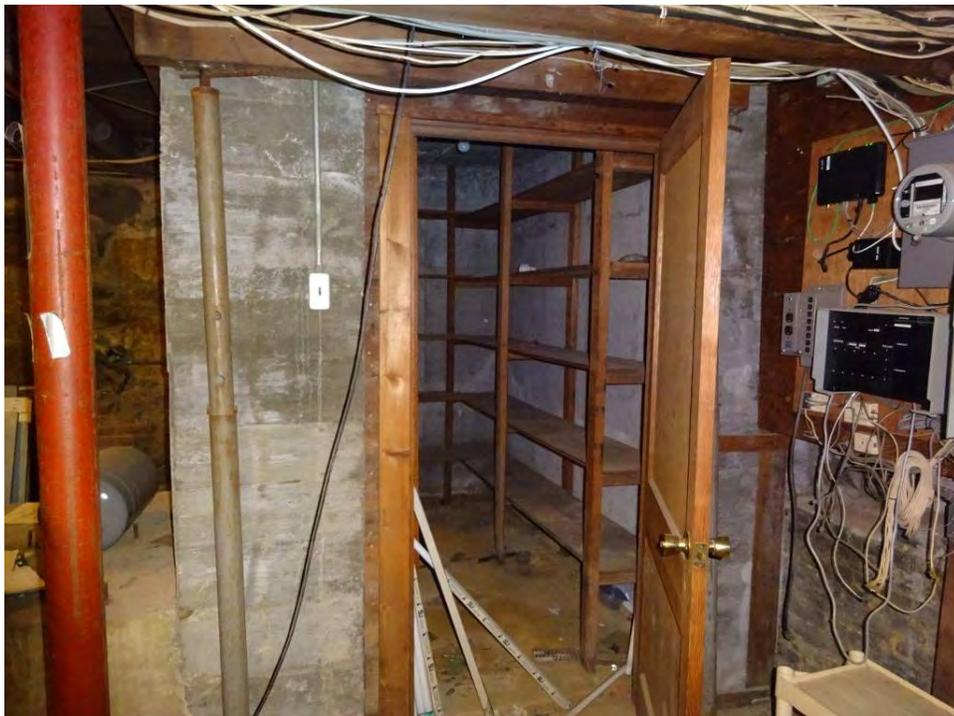
Photo 8
Concrete base of vault

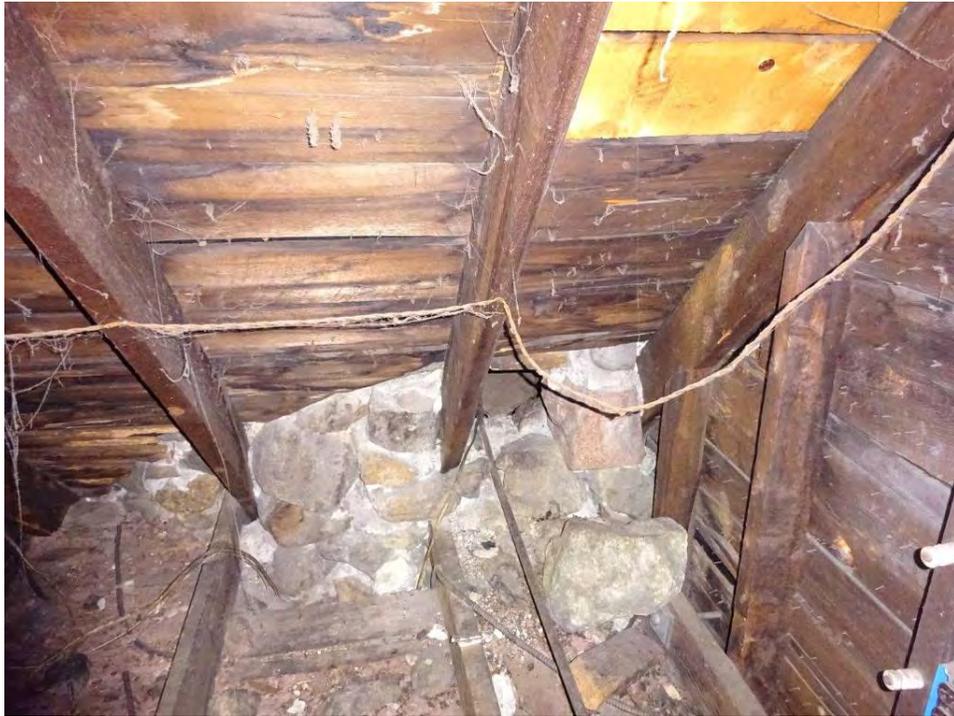
M3 A large stone has dislodged from the south side of the turret (see Photo #9 on Page 5 of the Appendix).

Photo 9
Dislodged stone at south edge of turret at roof level

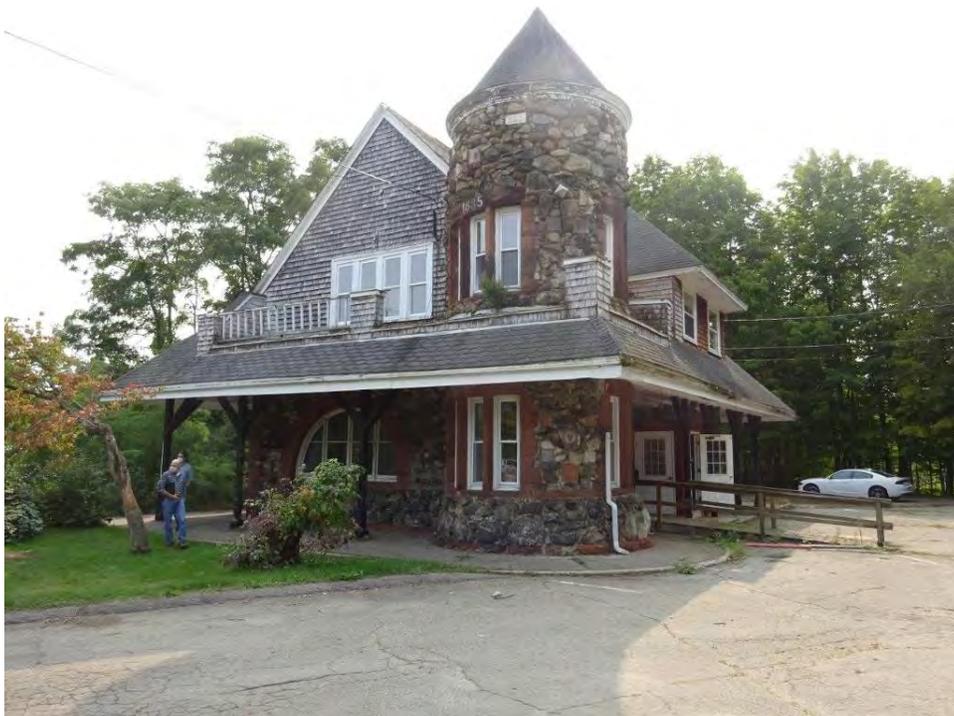
M4 Vegetation can be seen growing out of the east face of the turret masonry (see Photo #10 on Page 5 of the Appendix).

Photo 10: East elevation showing vegetation at north edge of turret

Photo 10
East elevation showing vegetation at north edge of turret
